Mooring Force Analysis Methods

...with Application to Breakaways
Caused by Passing Vessels

Jennifer K. Waters, Ph.D., P.E.

U.S. Naval Academy

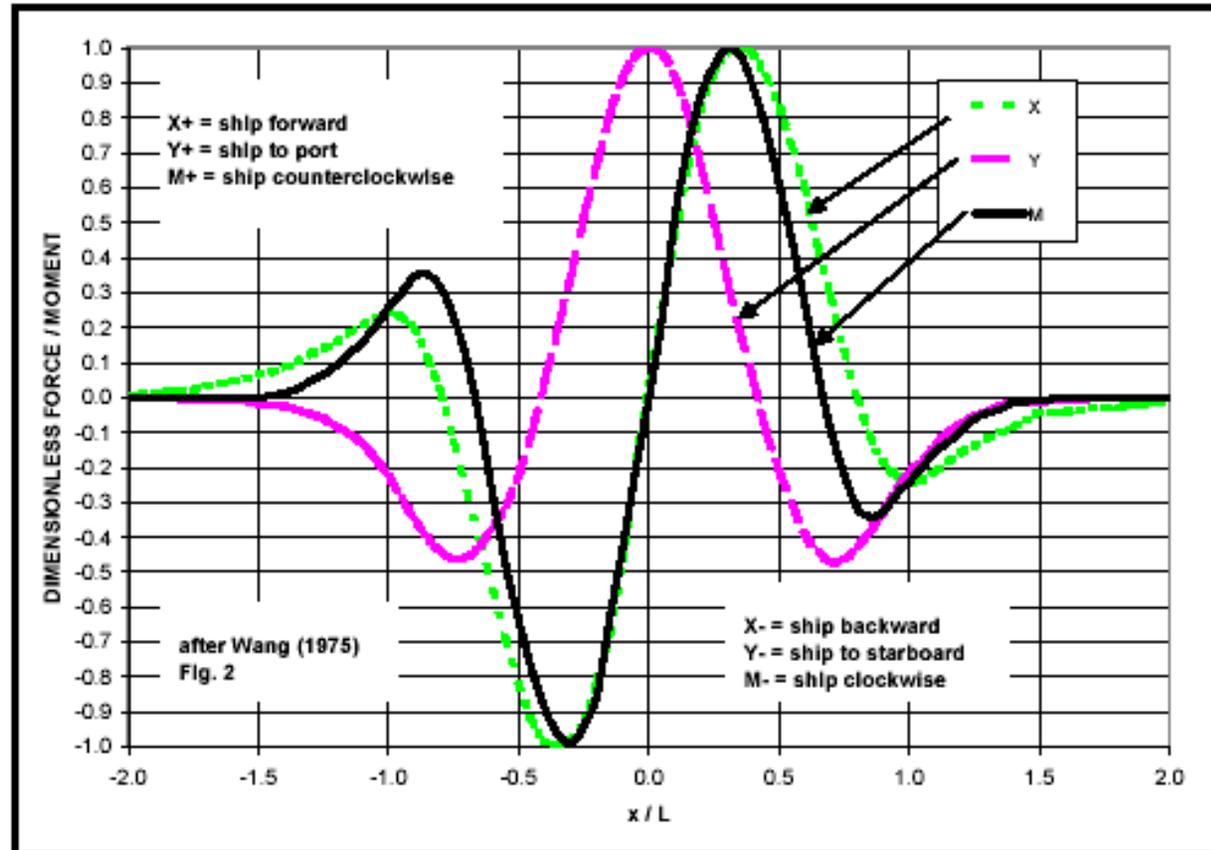
Figure 2.1-1 DIMENSIONLESS PASSING SHIP FORCING
ON MOORED SHIPS FOR DEEP WATER
(after Wang, 1975)

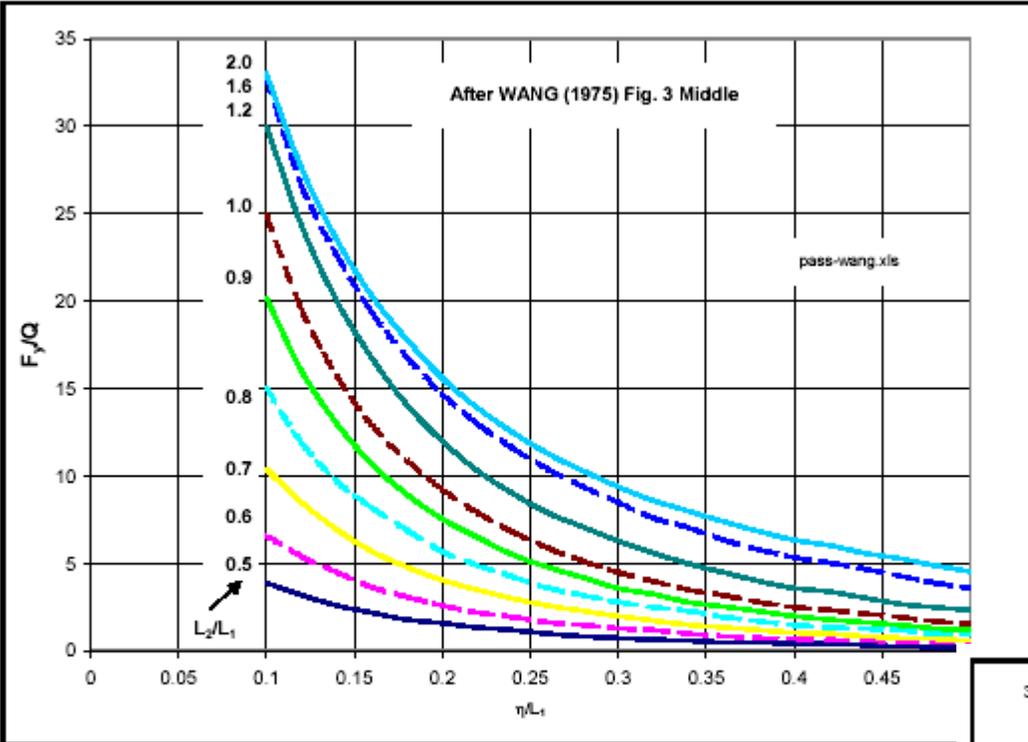
Figure 2.1-7. NON-DIMENSIONAL PEAK FORCE IN THE SWAY DIRECTION ON THE MOORED SHIP (after Wang, 1975) FOR DEEPWATER

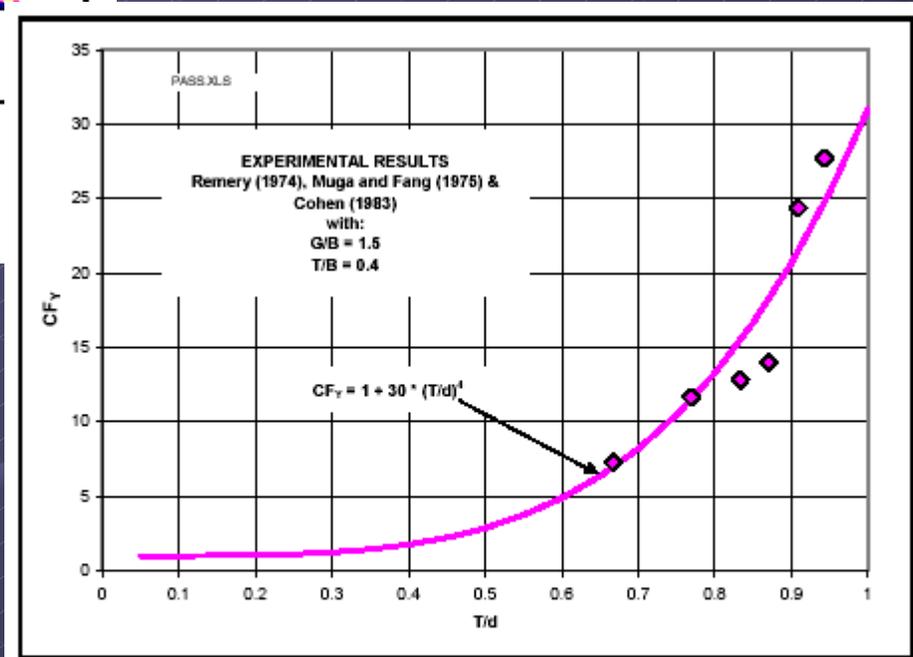
Figure 2.2-2. SAMPLE SHALLOW WATER CORRECTION FACTOR FOR THE PEAK SWAY FORCE

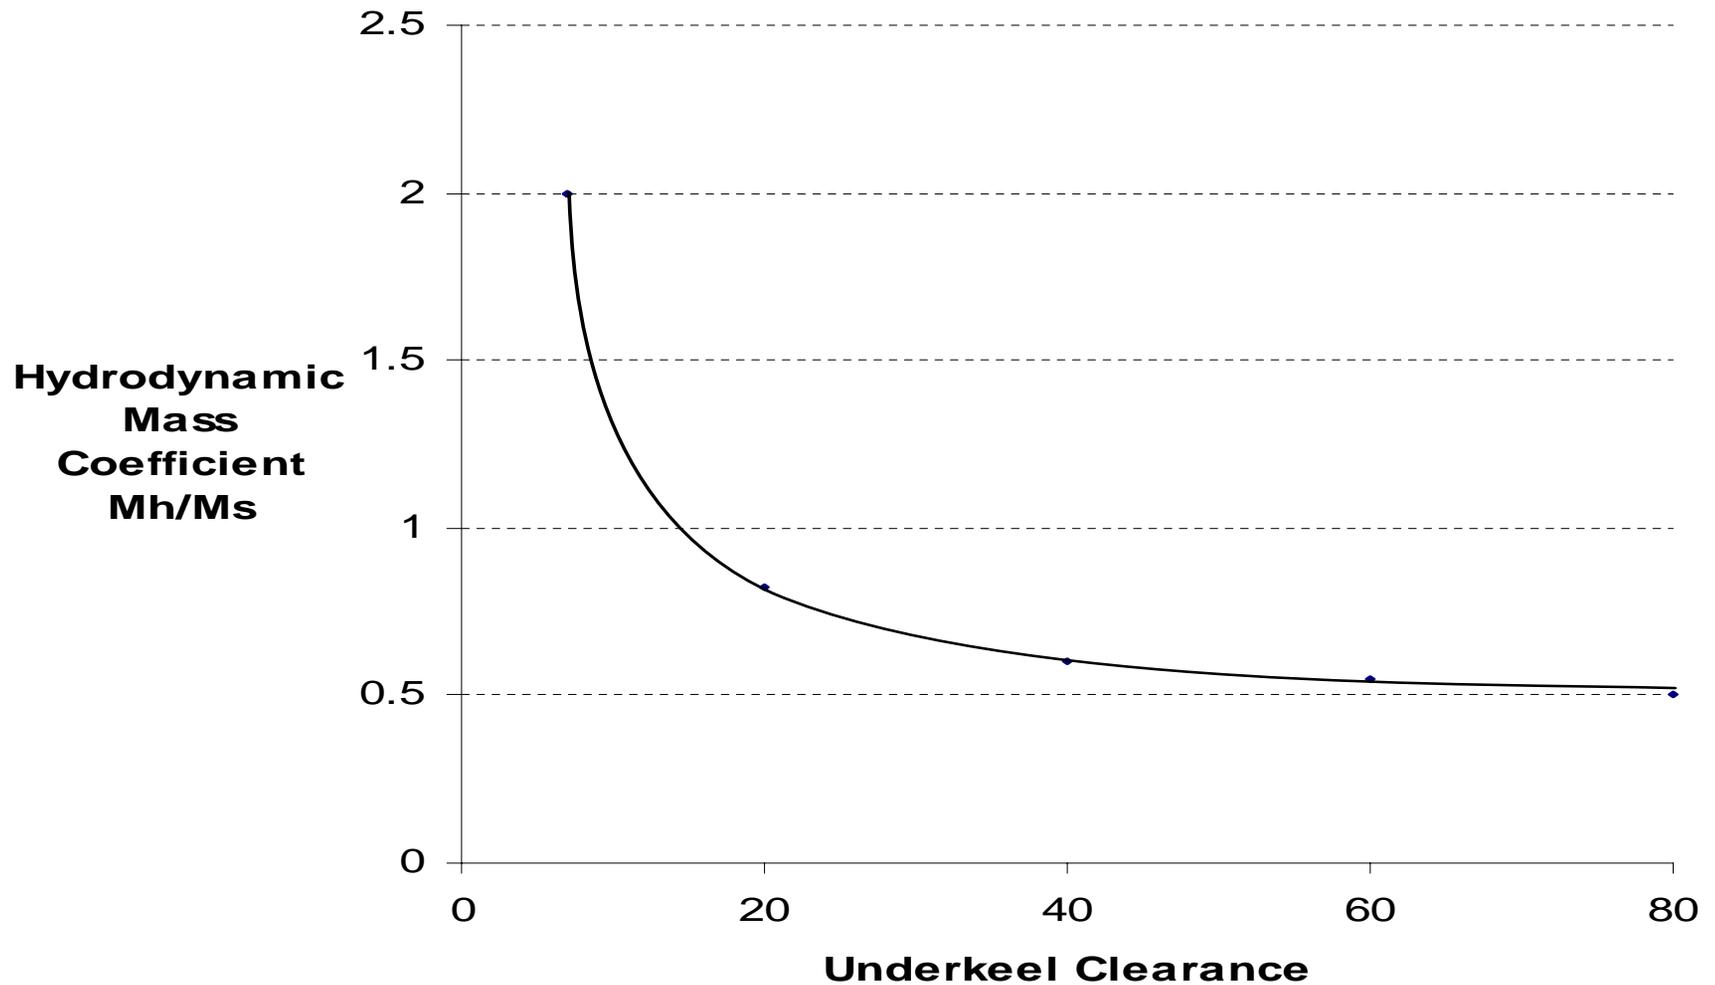
Model Ship in Translation Under Constant Pulling Force

after NATO, "Analytical Treatment of Problems of Berthing & Mooring Ships," 1971

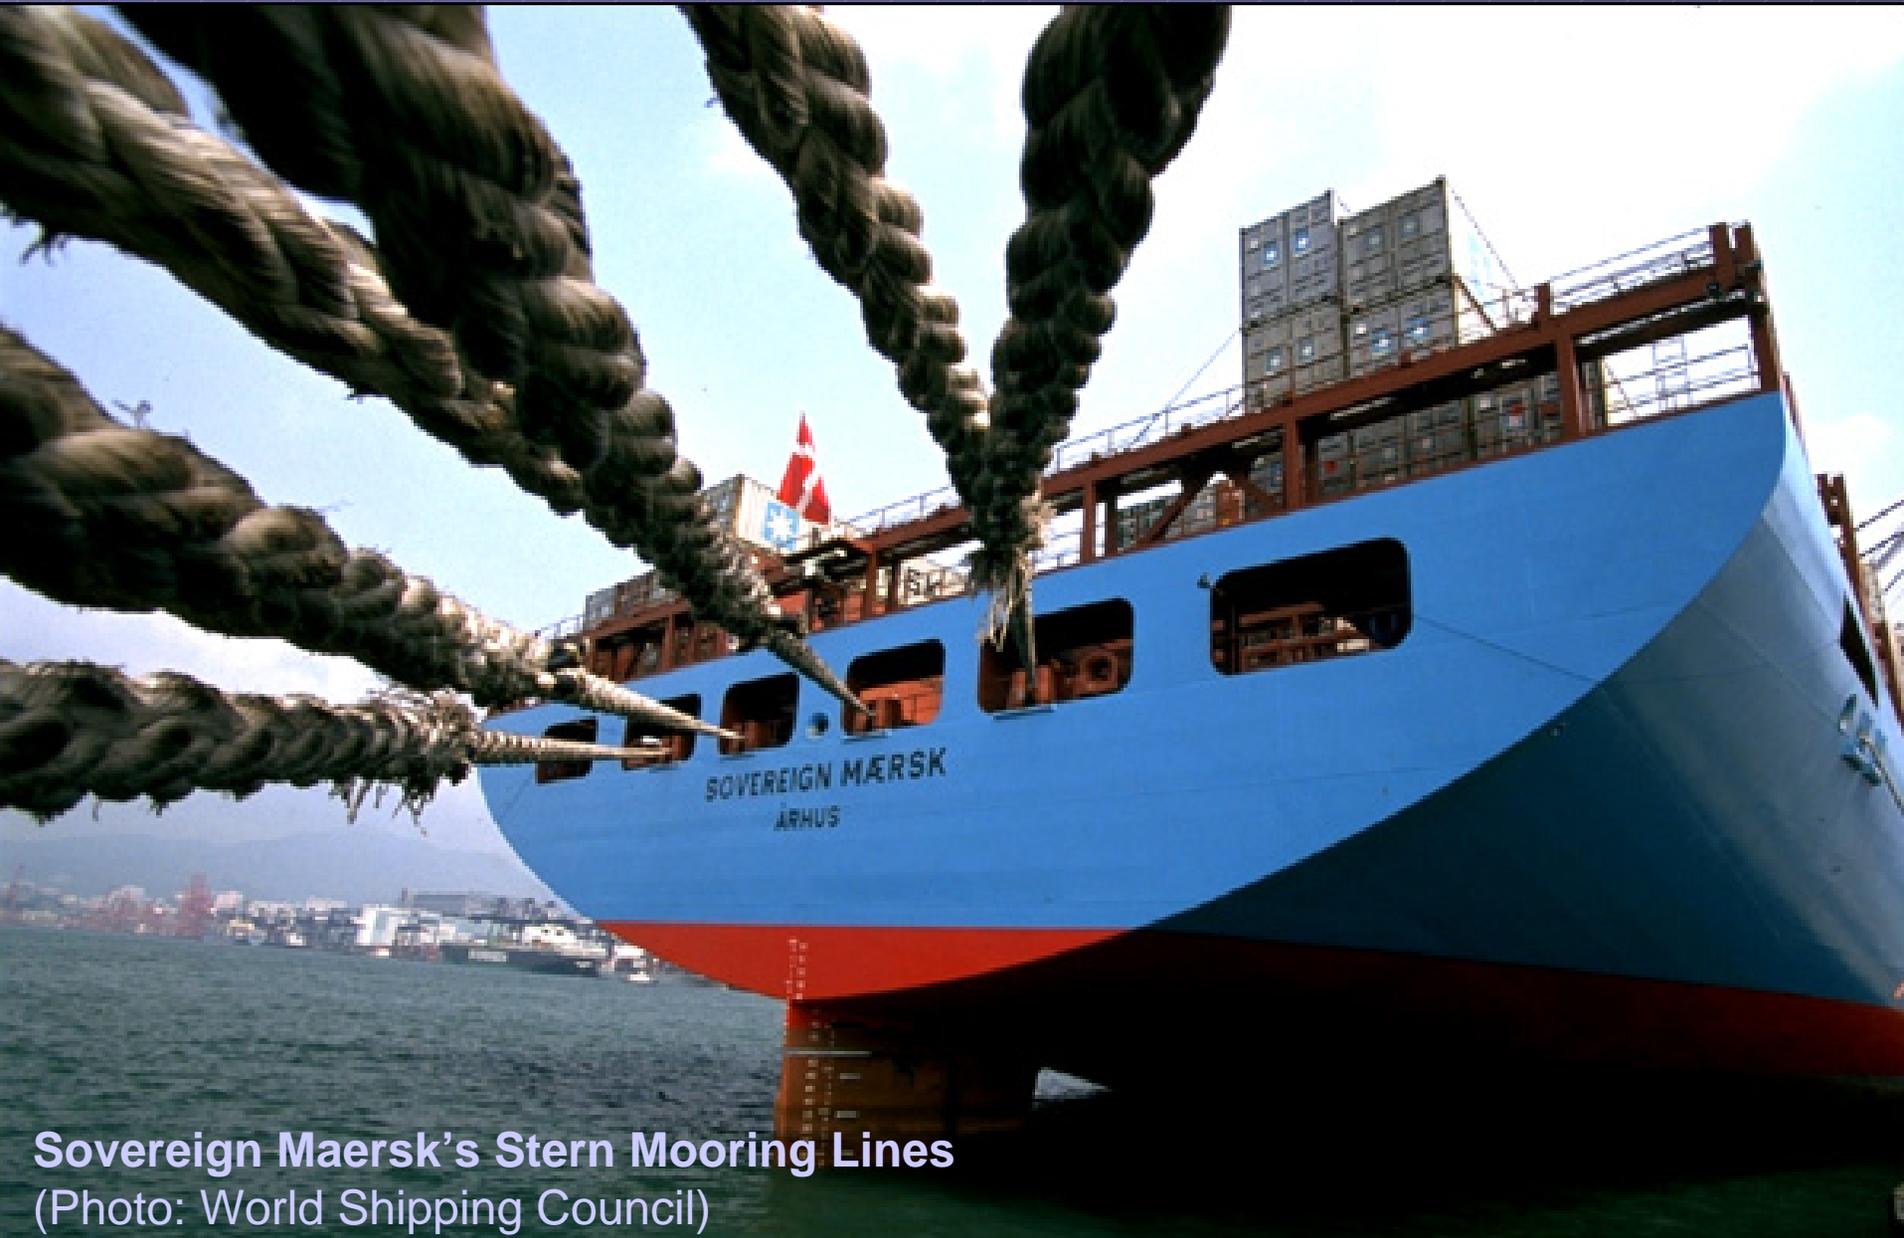
Sovereign Maersk's Stern Mooring Lines
(Photo: World Shipping Council)
