# DEMOPOLIS LOCK UPPER MITER SILL FAILURE

**RYAN REICH, P.E.**

Chief, Inland Navigation Section  
Operations, Mobile District

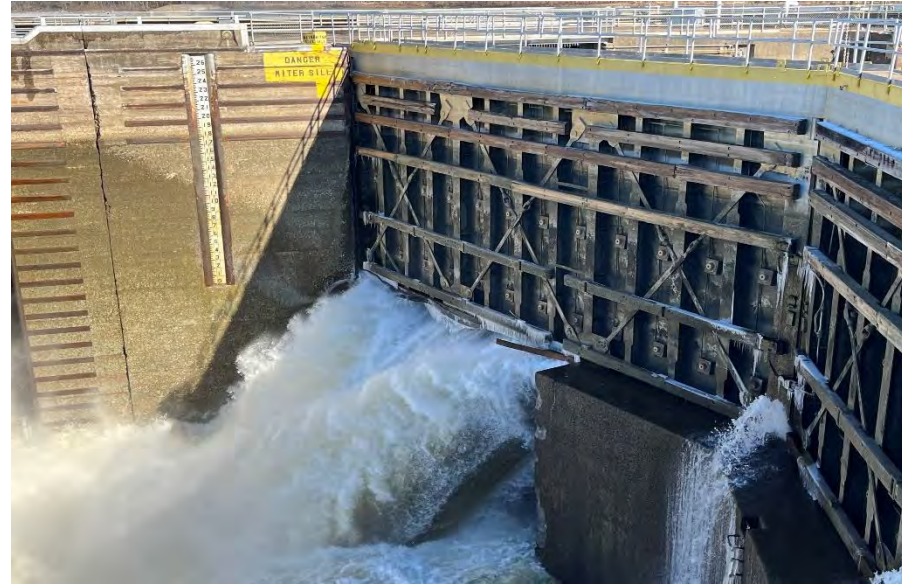
- January 16, 2024
  - Concrete sill under upper miter gate failed
  - Lower gate open and chamber at lower pool
- January 19
  - Lower miter gates closed under flow (assistance from Parker Towing)
- January 20
  - Placed stoplogs (assistance from TVA)

Breach Through Failed Sill

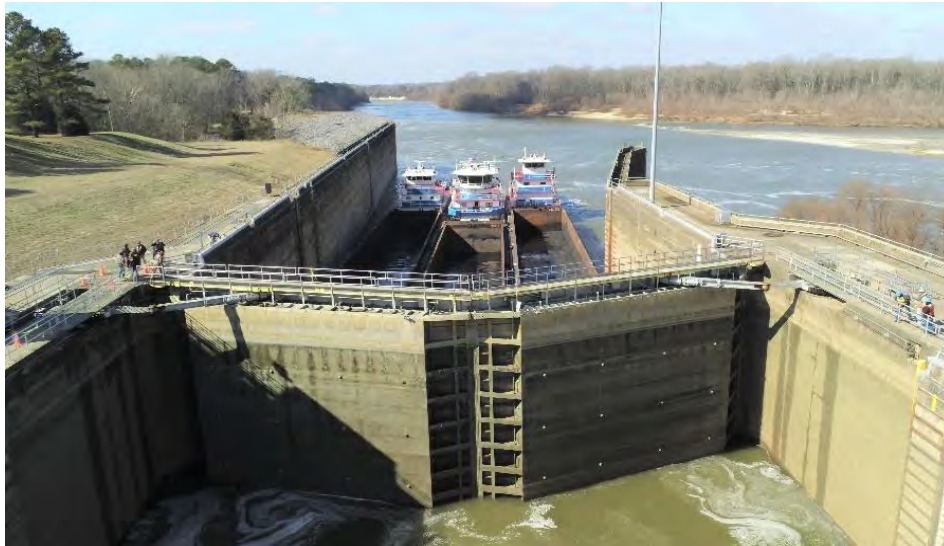
Lower Miter Gate Closure

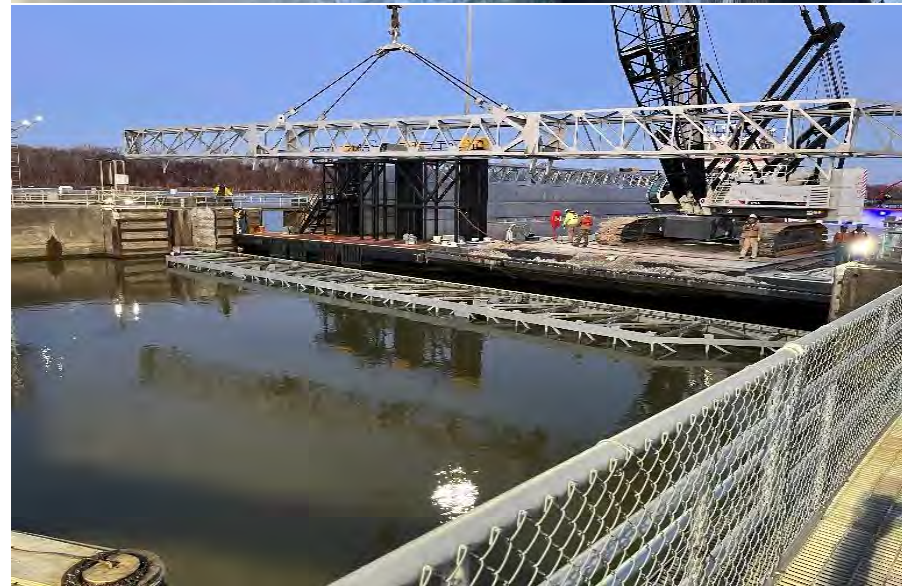
Placing Stoplogs

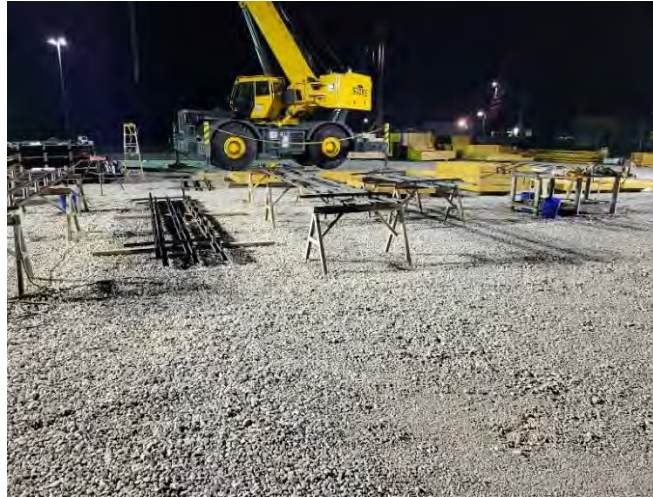
Initial Formwork Assembly

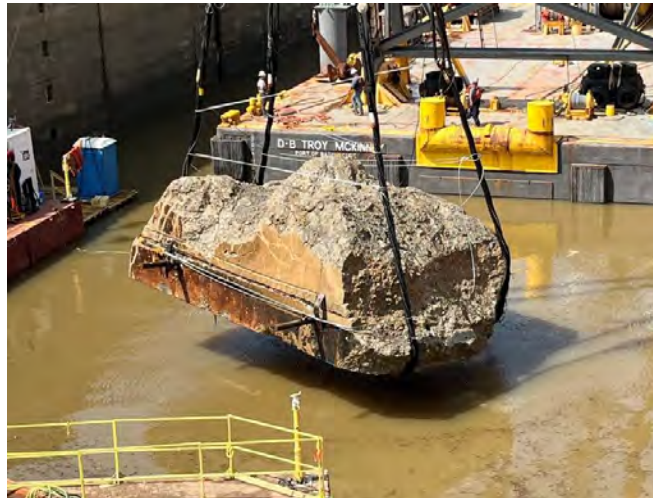
Debris Removal

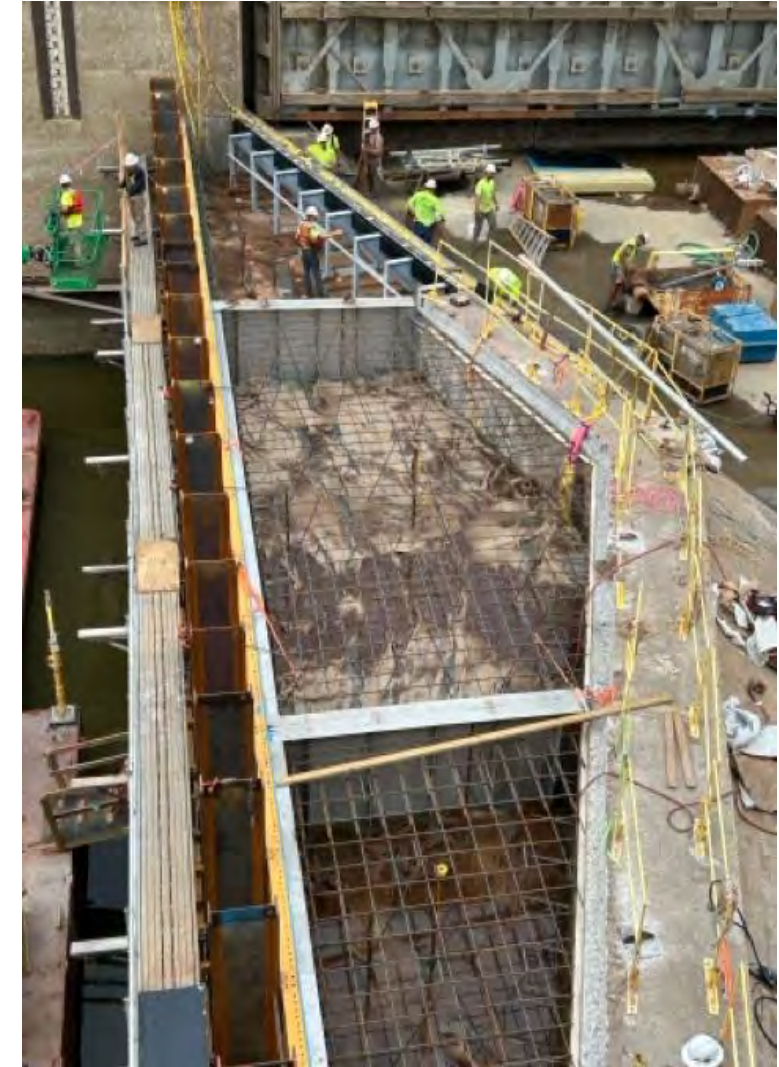
Reinforcement & Embedded Steel

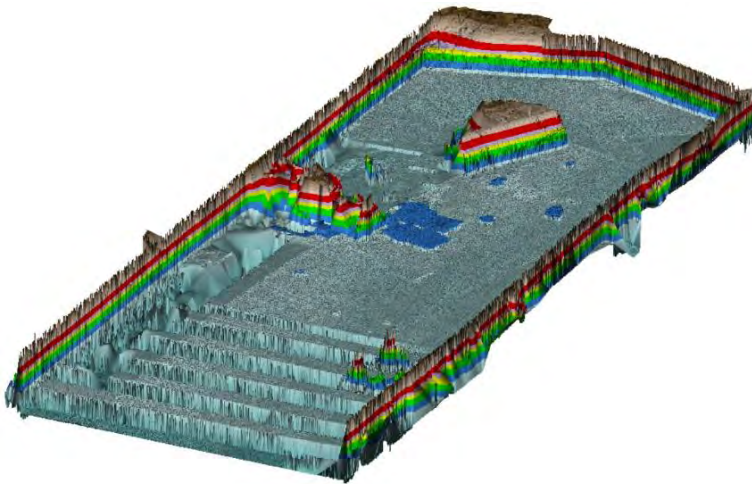
Survey of Damage

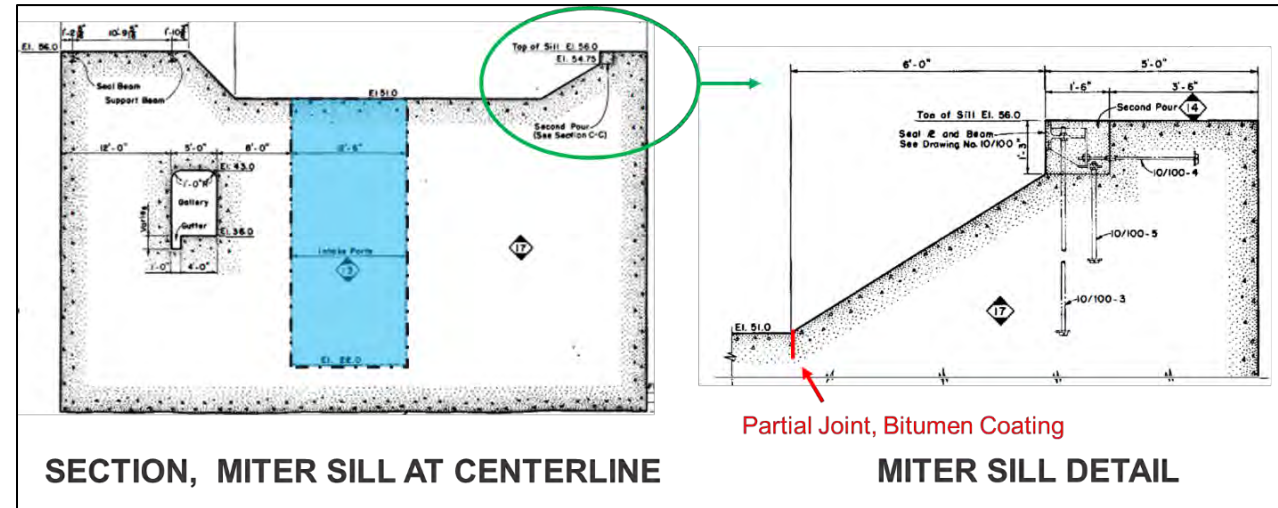
# NODE 1 – PARTIAL VERTICAL JOINT

- No issues had been found with the concrete matrix or aggregate
- Partial vertical construction joint at toe located in a high stress area w/o reinforcement

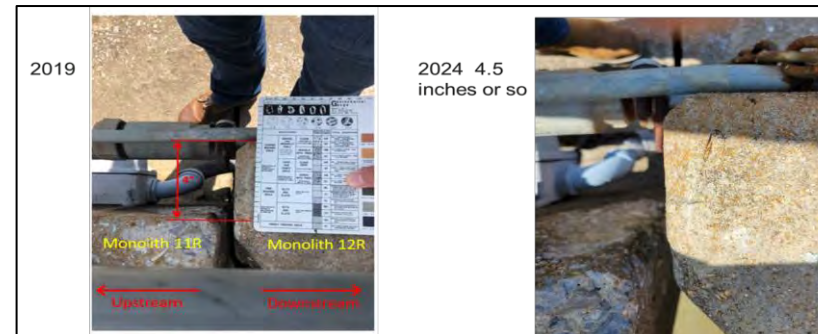
- Loads from the vertically framed upper miter gates during each lockage
- Barge Impacts
  - Top of sill when chamber lowered
  - Upper miter gate impacts
  - Adjacent monoliths transfer energy
- Temperature fluctuations
  - Expansion/contraction when chamber at lower pool

Monolith movement upstream of sill

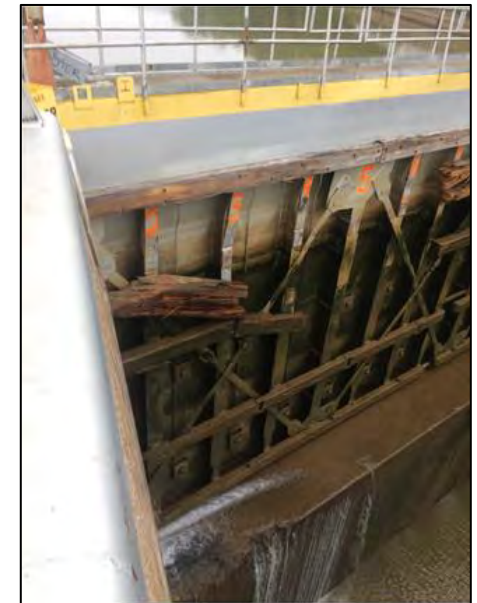
Gate & Sill Strikes

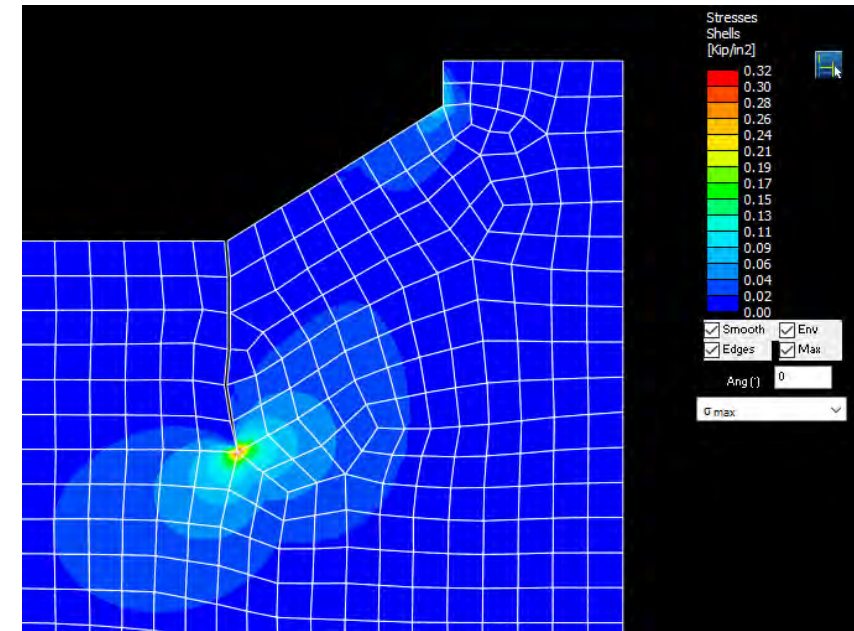
# NODE 3 – CRACK PROGRESSION

- Cracking starts at the partial vertical construction joint
- Continuous loading contribute to the propagation
- Tensile stress increased as the crack propagated
  - Eventually surpassed the capacity of the concrete

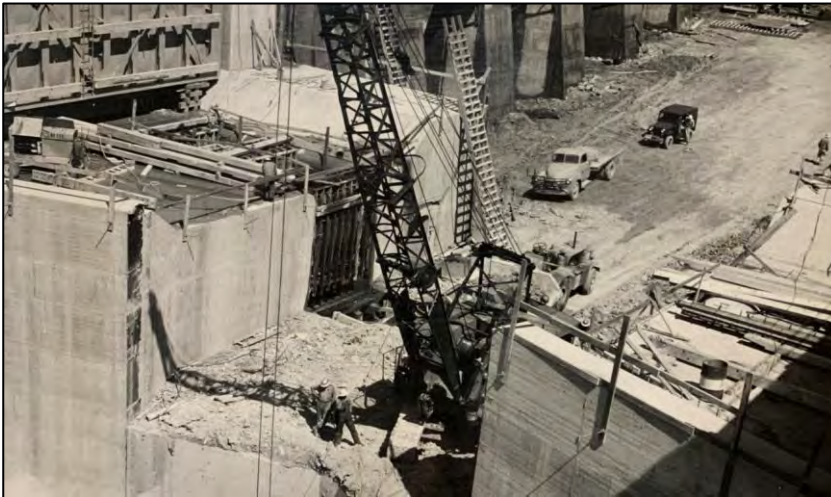
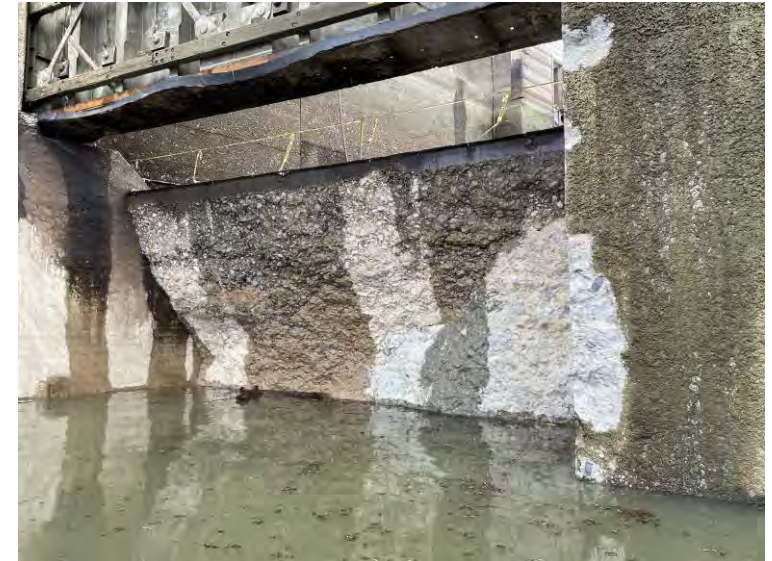
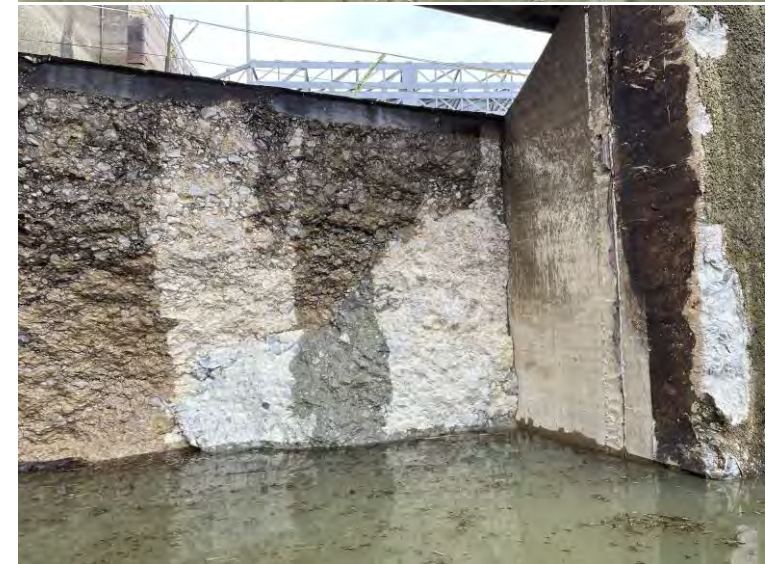
- Only gate damage was seal material
- Section of the concrete was a different color with a defined separation area
- The center monolith interface appeared to be very smooth, indicating that there was little adhesion between both the monoliths and the lock wall

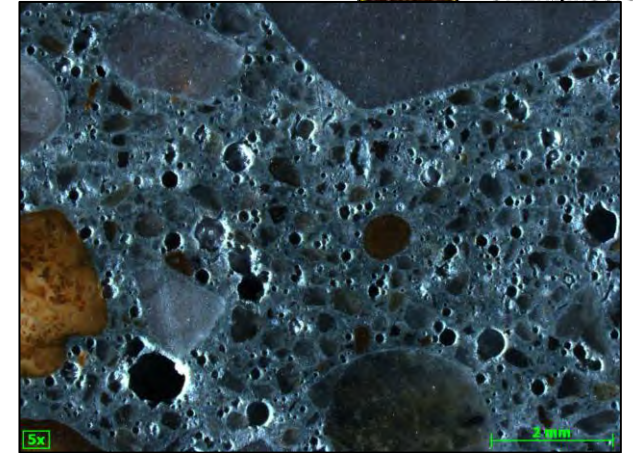
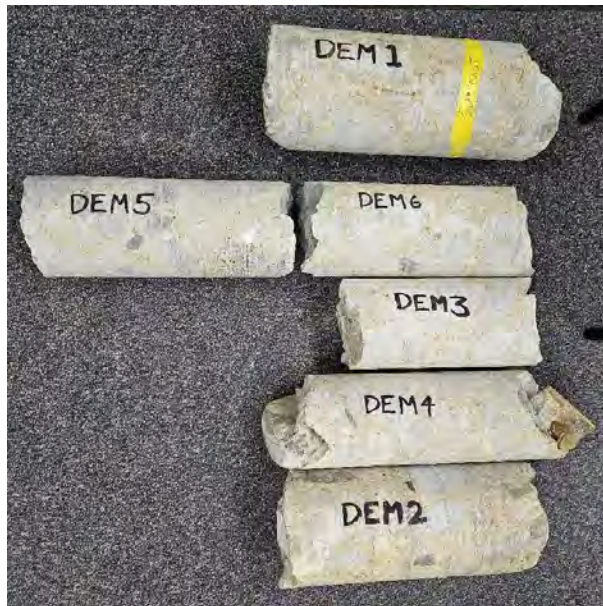
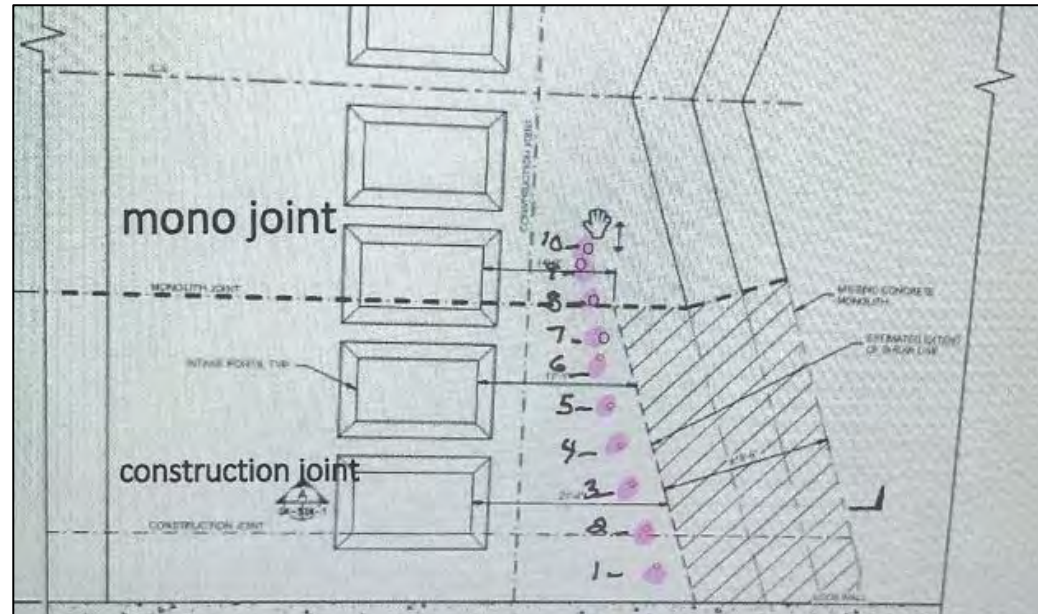
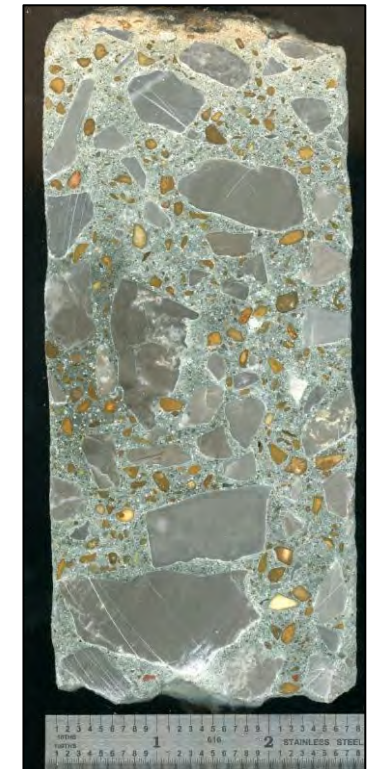
- 10 core samples were obtained for testing
  - Tested by O&M contractor and ERDC
  - Tested per ASTM C39 and ASTM 42
- Removed debris pieces indicated uniform concrete throughout with no obvious signs of internal deterioration
- Lab testing showed no issues with the matrix or aggregate and no signs of alkali-aggregate reaction (AAR).

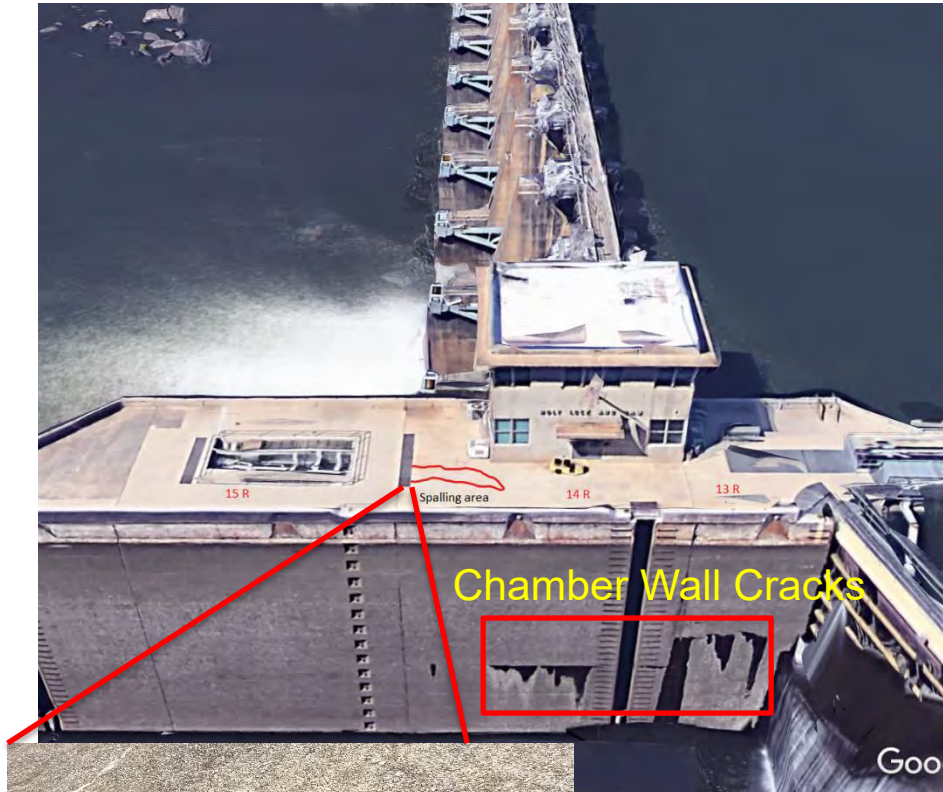
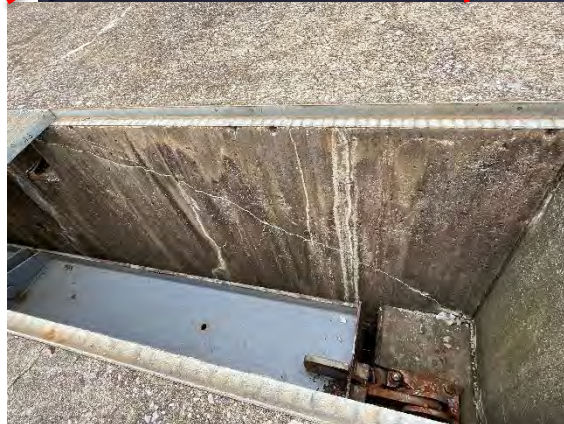
- BWT PMO notified MDO of changes in observed cracks in river wall Monolith 14R
  - Increased water flows through machinery room cracks
  - New cracks and spalling in bulkhead slot
  - Failure of gallery sump pumps

New Crack in  
Upstream  
Bulkhead Slot

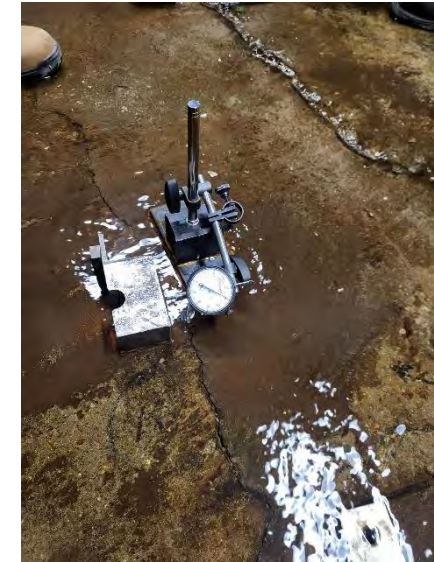
Crack in Machinery Room Floor

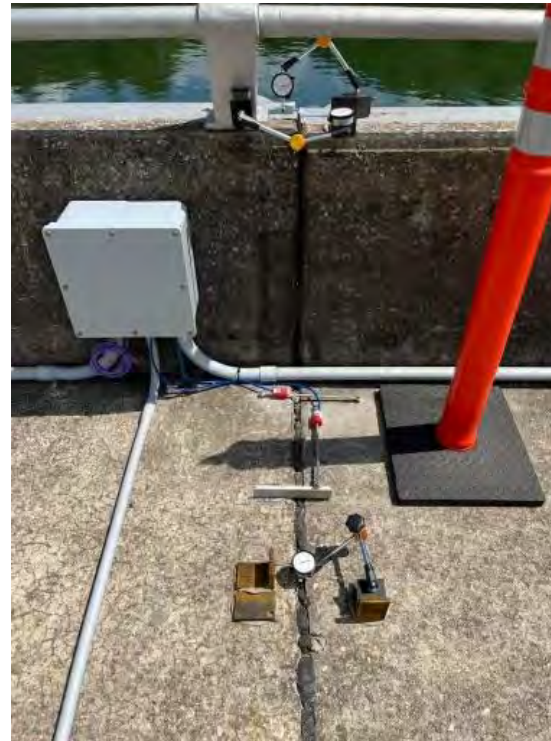
Instrumentation at Monolith Joint

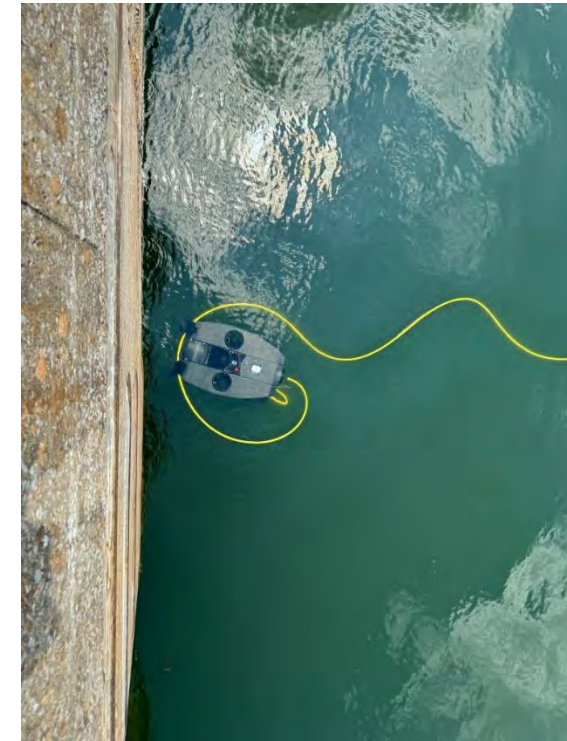
ROV in Chamber

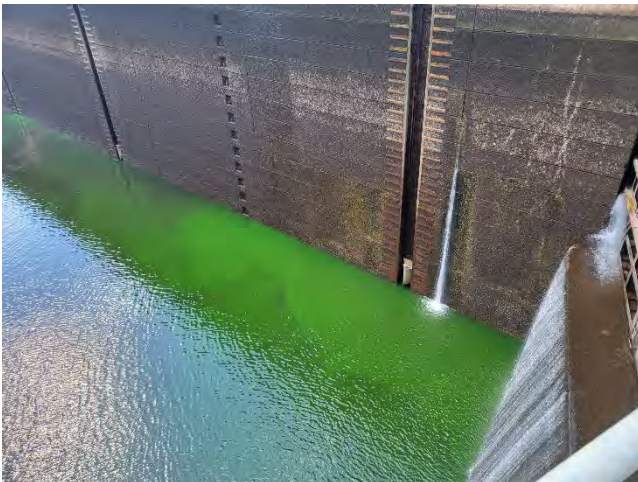
Dye Observed from Leaks in Lift Lines Along 14R

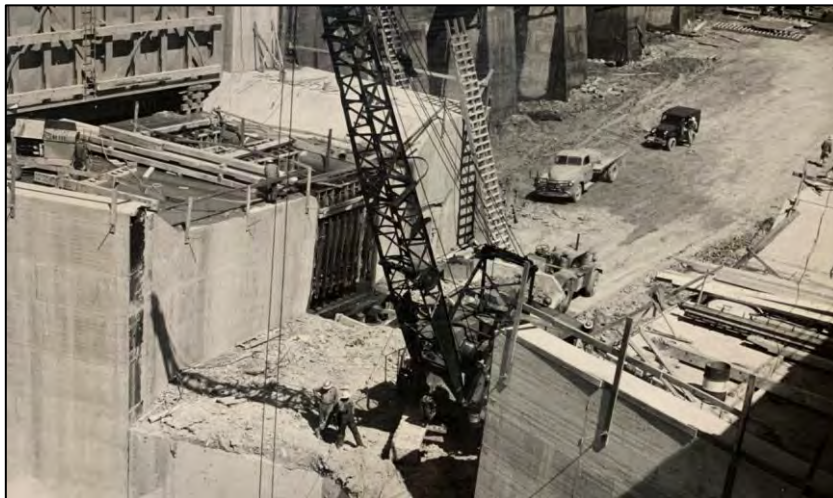
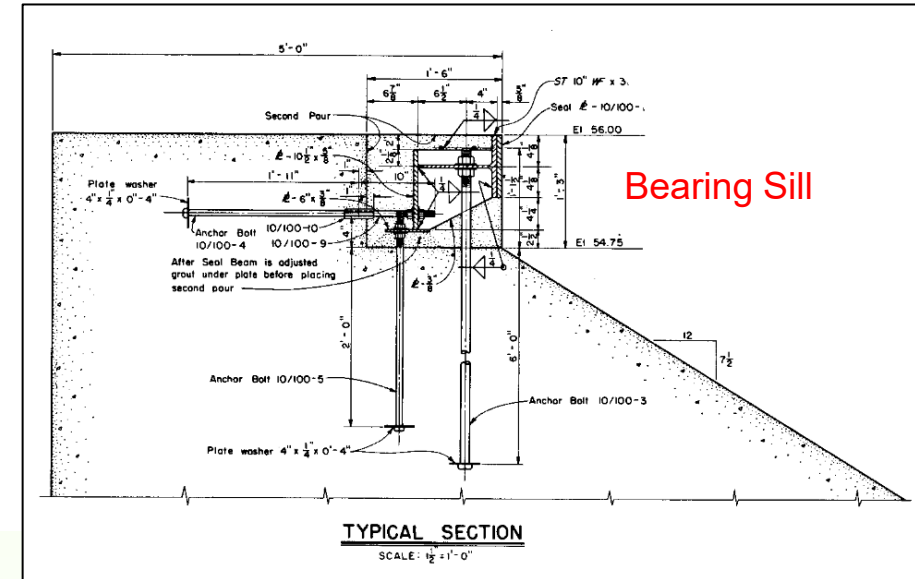
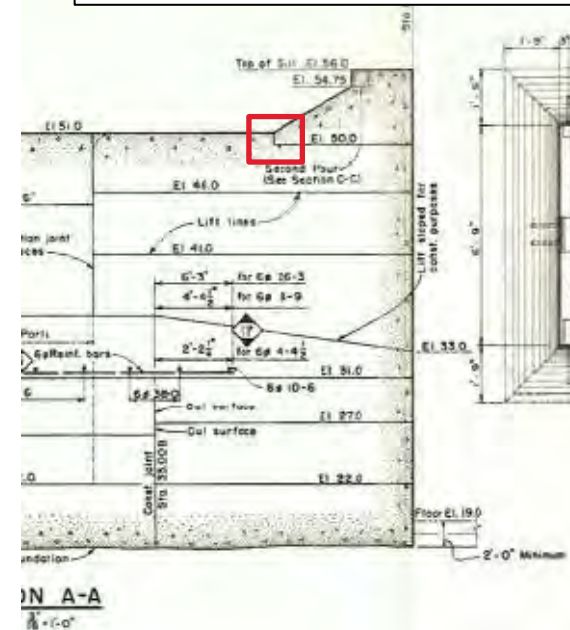
# MITER SILL DESIGN

- Poured in monoliths consisting of 5ft lifts
- Bearing sill consisted of a steel beam with embedded vertical and horizontal anchors
- Vertical construction joint at the base of the slope at the end sill
- No reinforcement
- Designed to support the water load transmitted by the bottom girder of the vertically framed miter gates.
