*PRESENTATION  
TO THE  
INLAND WATERWAYS USERS BOARD*

*LOCKPORT POOL  
CHICAGO SANITARY & SHIP CANAL  
ILLINOIS WATERWAY*

*BY  
GARY LOSS, P.E.  
ROCK ISLAND DISTRICT*

*JULY 13, 2006*

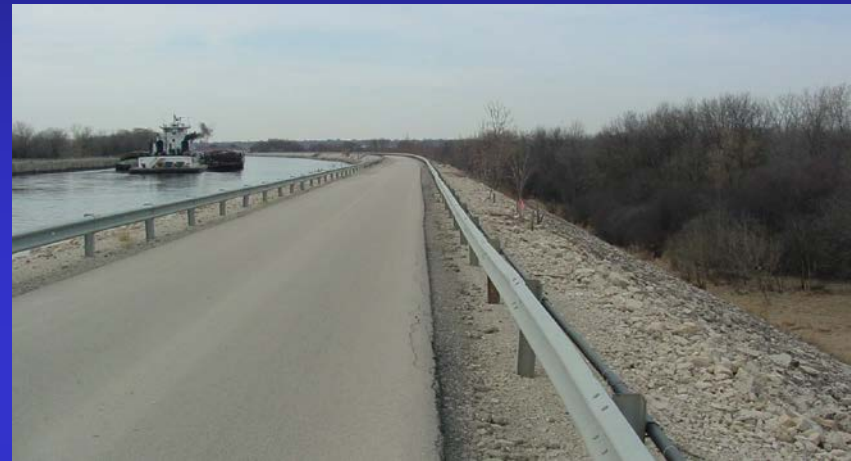
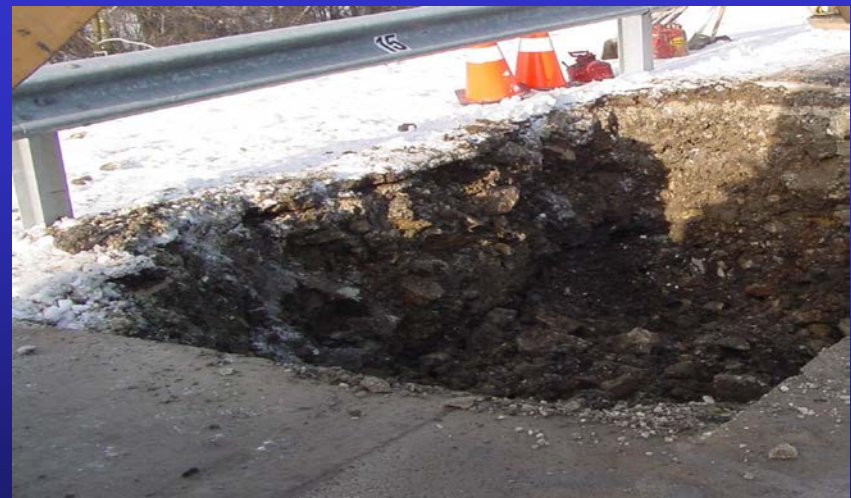
# Approach Dike (Right Descending Bank)

- **Constructed in early 1900's**
  - 4,300 feet in length above the Powerhouse.
  - Acts as high-hazard dam
- **Early CSSC pool raise places canal levels above the core wall top.**
- **Constant seepage with chronic sinkhole development.**

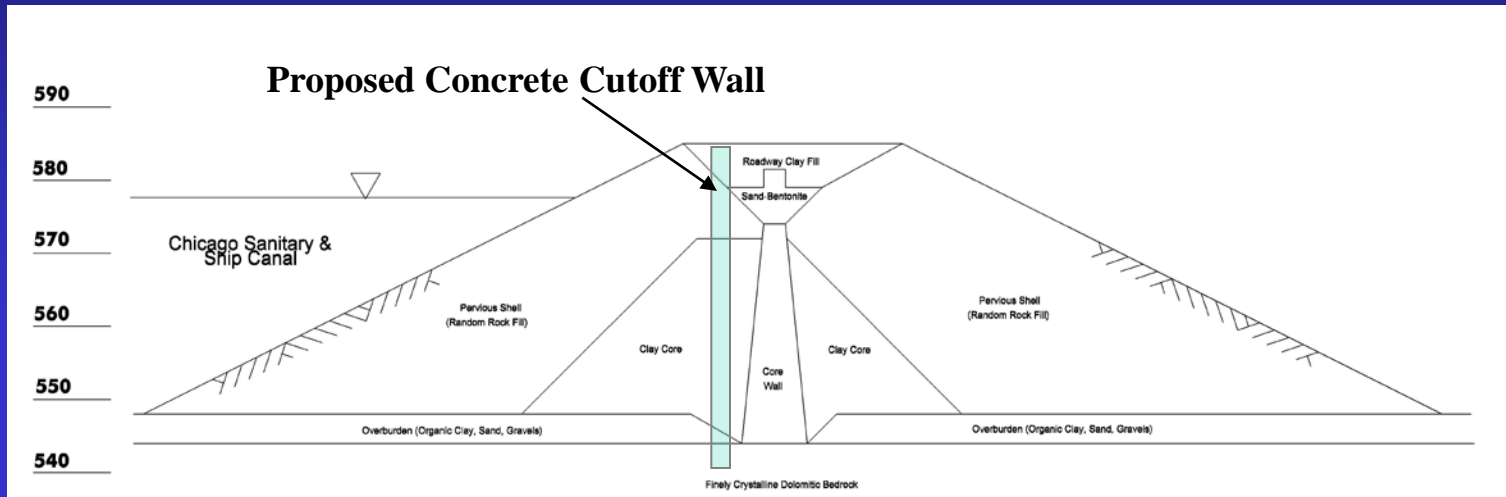
# Approach Dike

- 1992 – Sand/bentonite cap installed. Seepage continued.
- 1997 – 100-foot length of test sheet pile wall installed at location of a major sinkhole. Seepage continues.

- Must be done while maintaining navigation & hydropower
- Concrete seepage cutoff placed via slurry trench
- \$23.6 million (Rehab/TF)

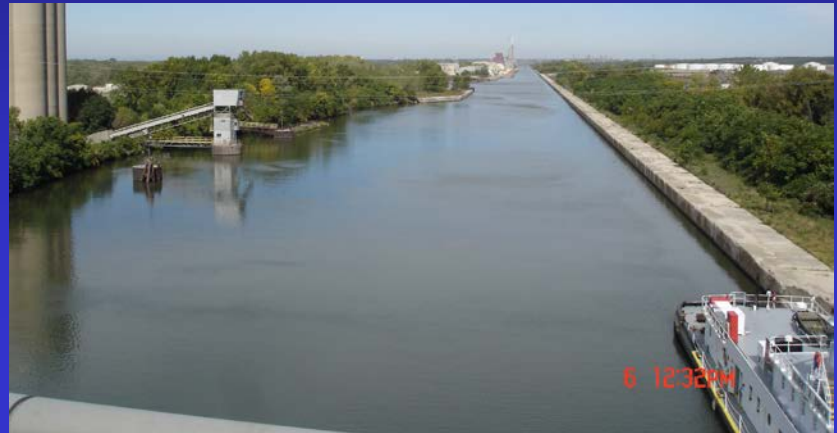
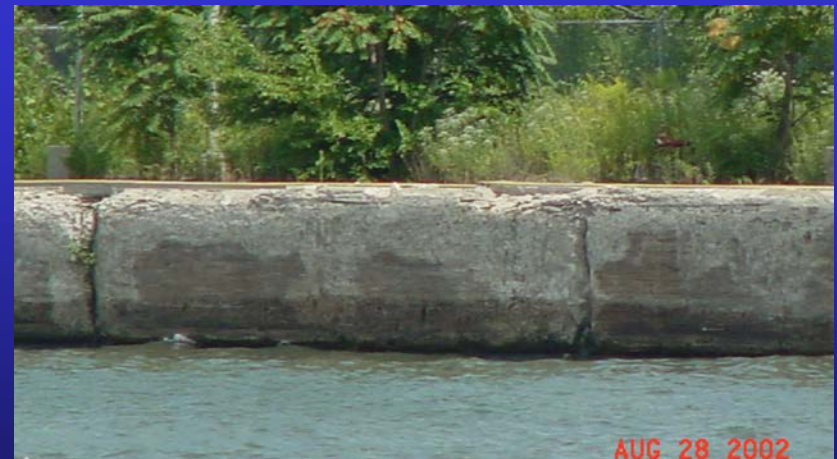
# Concrete Canal Wall

- Lockport Pool reach has 399 monoliths, 60 with barge check posts.
- Acts as a high-head dam with maximum 40-foot head.
- Serious concerns of structural stability and integrity.

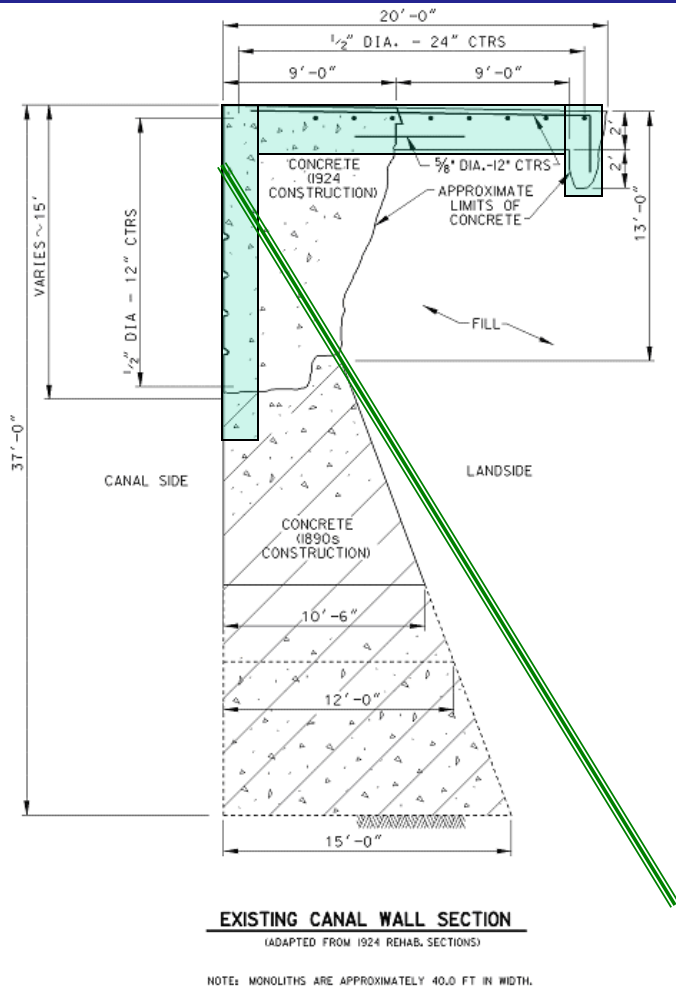
# Concrete Canal Wall

- 1890's – lower 22 feet, lime cement concrete, 800 psi
- 1924 – upper 15 feet, Portland cement concrete
- No bond between the 2 parts

- Must be done while maintaining navigation and hydropower
- Pre-cast vertical face panels
- New horizontal tie-back concrete
- Rock anchors
- \$87 million in repairs (Rehab/TF) for first 3 miles

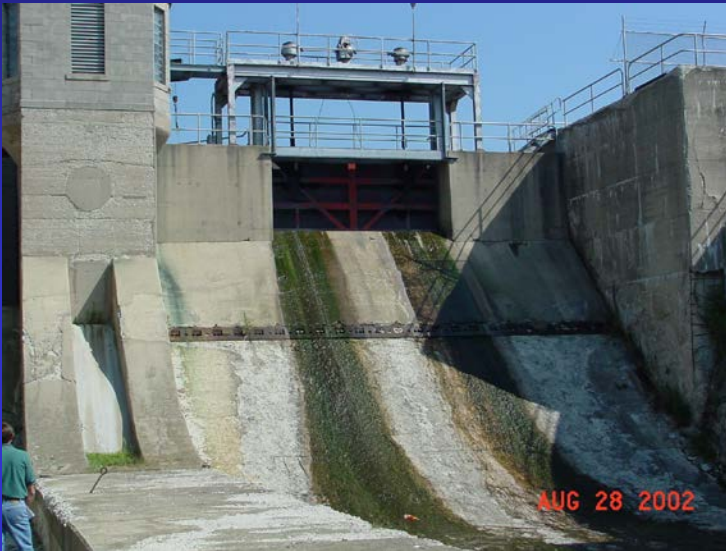
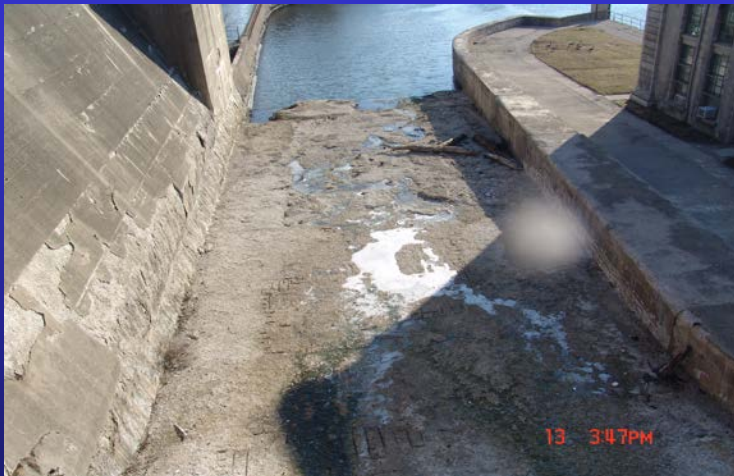
# MWRD Powerhouse

- **48-foot spillway**
  - Spillway chute concrete is in very poor condition.
  - Used on limited basis to pass debris.
  - MWRD wants to use for routine pool regulation.
- **12-foot spillway**
  - Bulkhead concrete deterioration
- **Rehabilitation Scope**
  - No Powerhouse work
  - \$1.2 million in spillway concrete replacement (O&M)

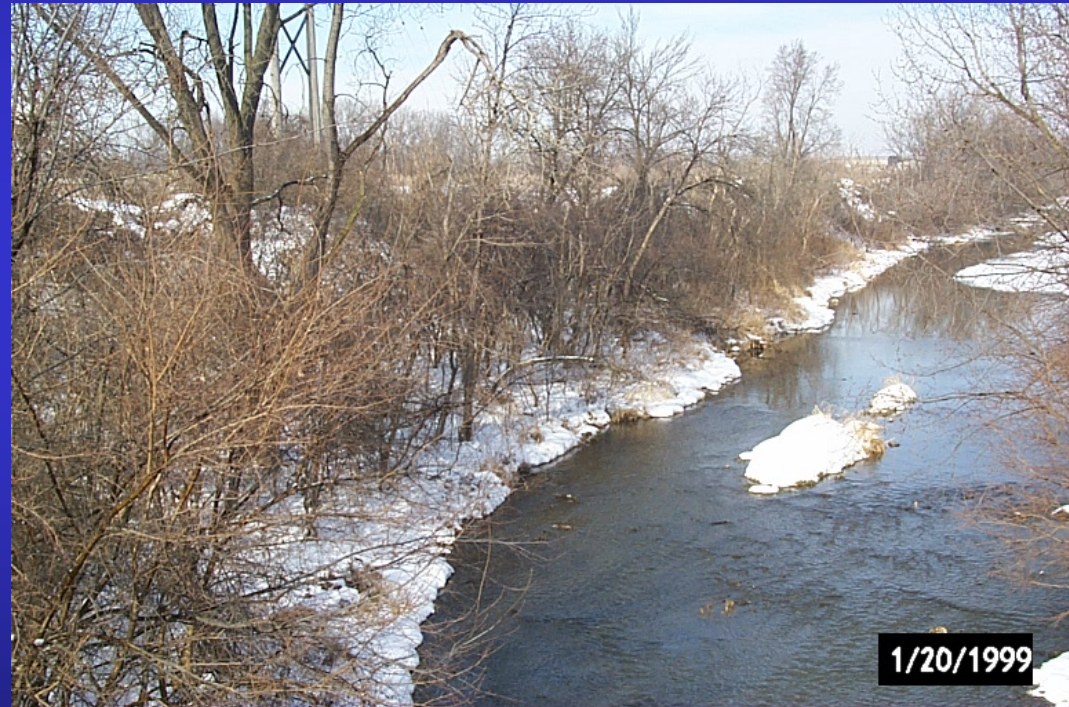
# Embankment Clearing

## ■ Massive embankment overgrowth

- Became Corps' responsibility in 1984
- Impossible to reliably monitor or inspect
- On MVR Critical O&M Backlog List

- Clearing of trees and brush
- \$1.8 million (O&M)
