Fire Background

Altered Hydrology

Watershed Response Geomorphology

Technical Assistance Reports

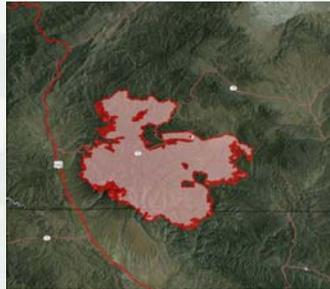
Las Conchas
~ 156,600 acres
High – 33,000 ac.
Mod. – 54,000 ac.
Low – 48,000 ac.

Little Bear
~ 45,000 acres
High – 12,500 ac.
Mod. – 11,000 ac.
Low – 13,200 ac.

Whitewater – Baldy
~ 297,000 acres
High – 39,000 ac.
Mod. – 38,000 ac.
Low – 66,000 ac.

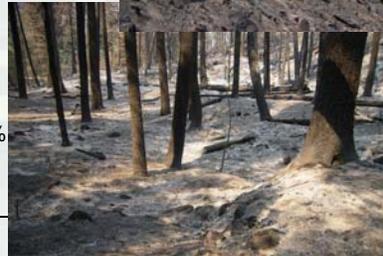
- Vegetation
- Organic layer
- Water repellent soil layers
- Altered runoff characteristics
 - ▶ HEC-HMS used to model runoff
 - ▶ Very Large Areas
 - ▶ Burn Severity mapping
 - ▶ Severe Slopes
 - ▶ Infiltration Adjustments:
 - Severe – infiltration set to zero
 - Moderate – infiltration reduced by 50%
 - Low – infiltration reduced by 20%

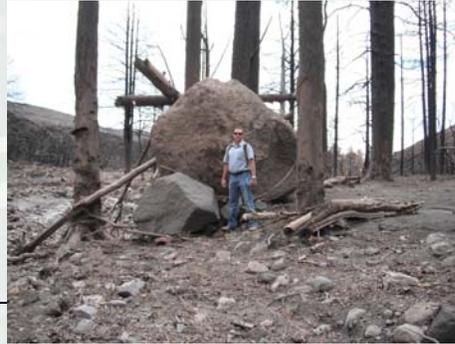
**Cochiti Canyon
Post-Flood
August 25, 2011**

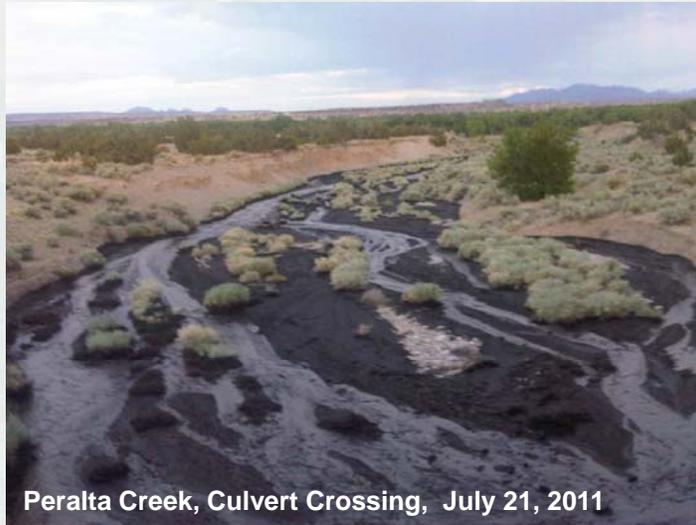
Peralta Creek, Culvert Crossing, July 21, 2011

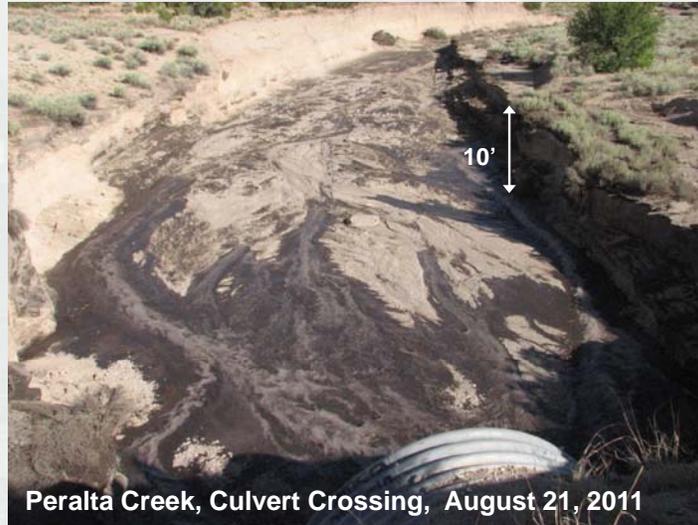
Peralta Creek, Culvert Crossing, August 21, 2011

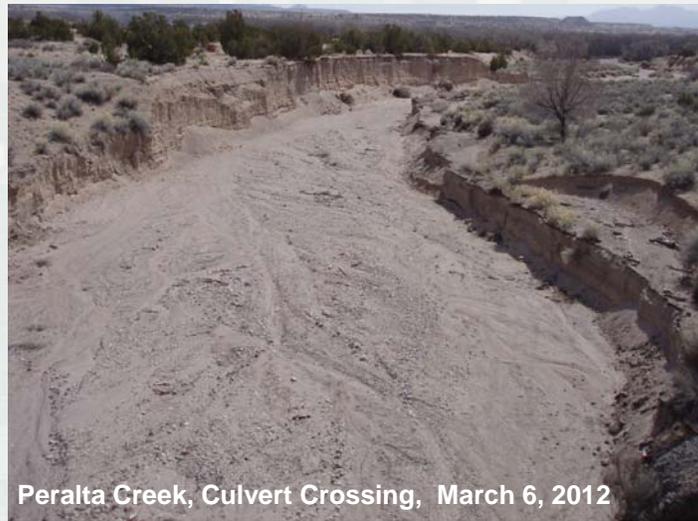
Peralta Creek, Culvert Crossing, March 6, 2012

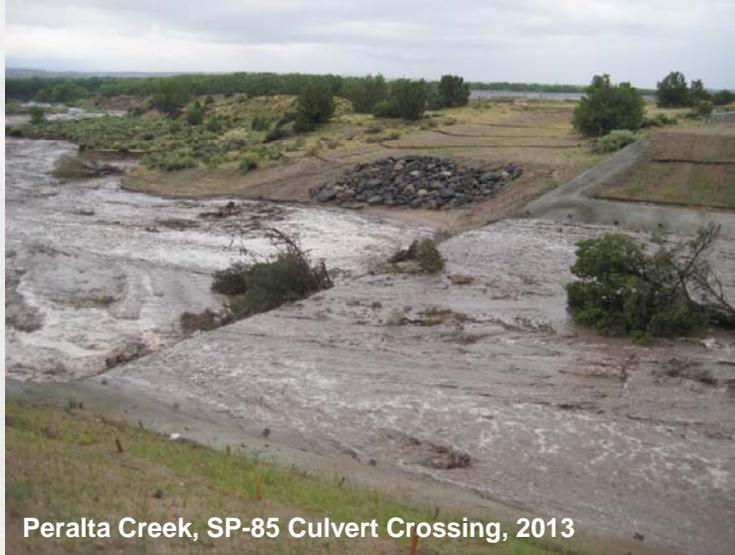
Peralta Creek, SP-85 Culvert Crossing, 2013

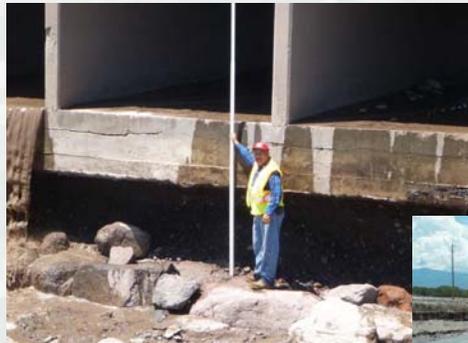
Culvert Crossing Kee St. –
Santa Clara Creek
July 26, 2013

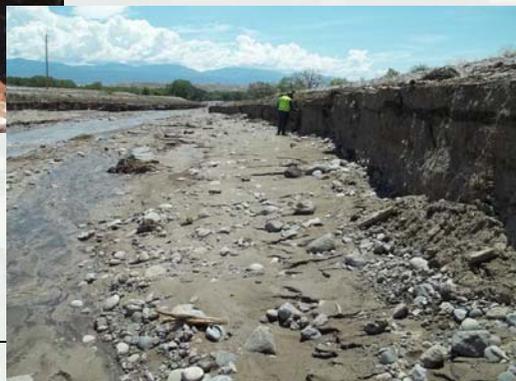
Village Reach -
Santa Clara Creek
July 26, 2013

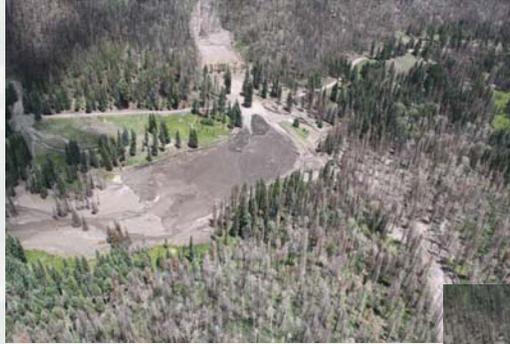
**Pond 4 – Santa Clara Canyon
July 26, 2013**

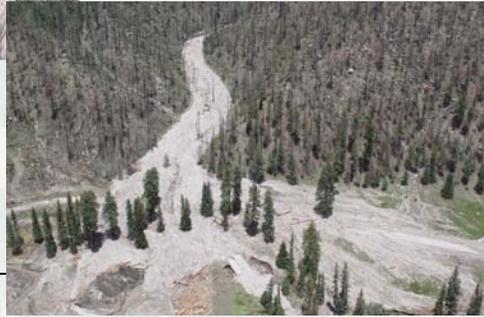
**Pond 3 – Santa Clara Canyon
July 26, 2013**

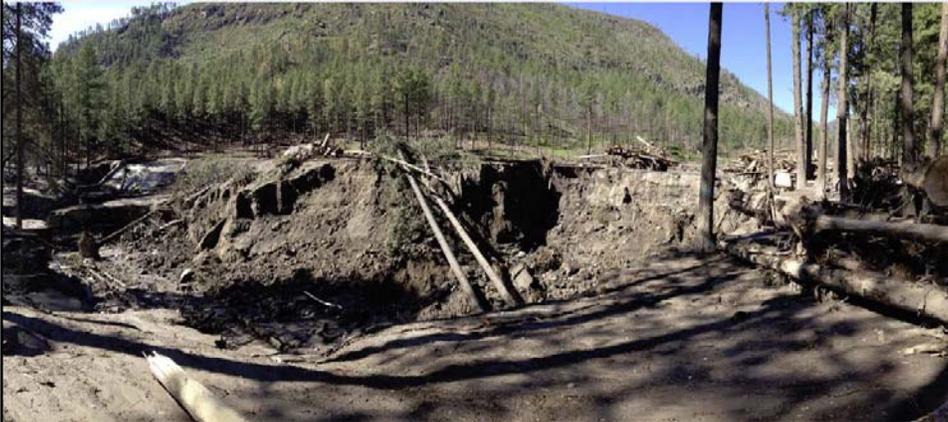
Pond 1 – Santa Clara Canyon – July 26 2013

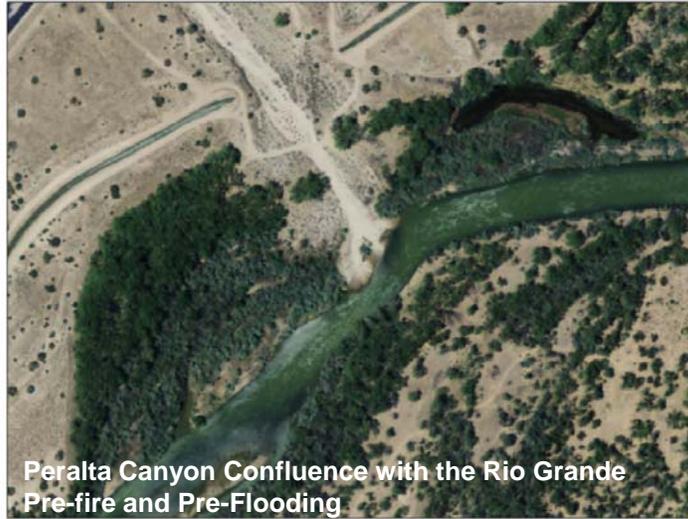
Peralta Canyon Confluence with the Rio Grande
Pre-fire and Pre-Flooding

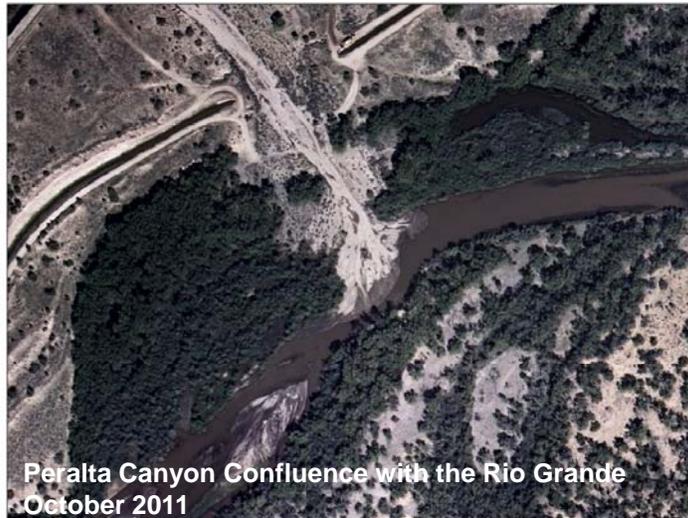
Peralta Canyon Confluence with the Rio Grande
October 2011

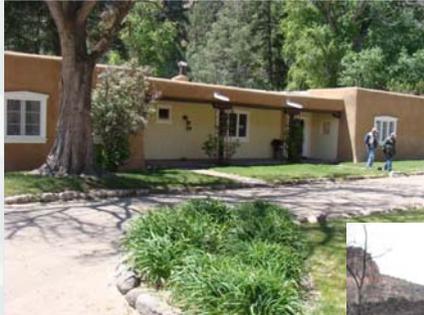
Dixon Conference Center
Pre-Fire

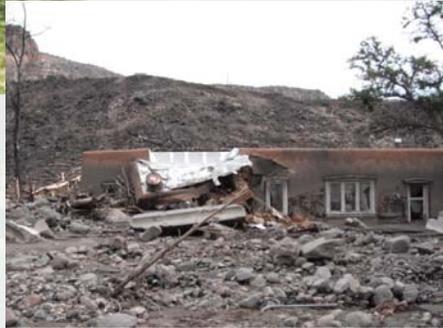
Dixon Conference Center
Post-Fire & Post-Flood

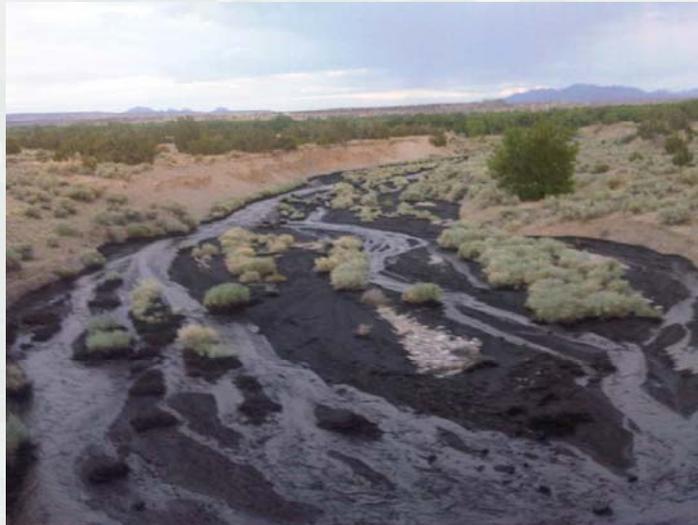
Peralta Creek Culvert Crossing

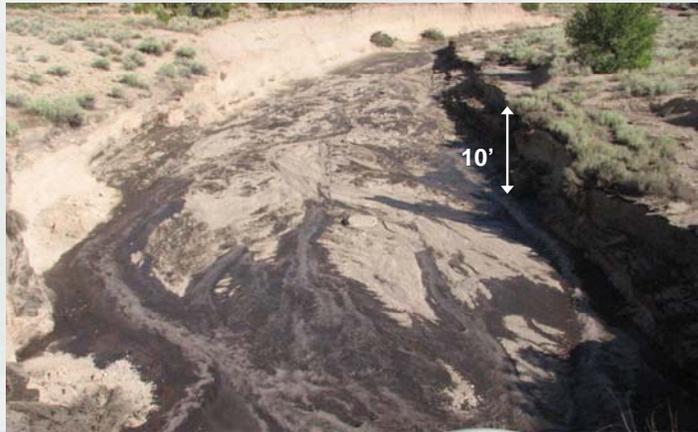
Peralta Creek Culvert Crossing
One Monsoon Season Later

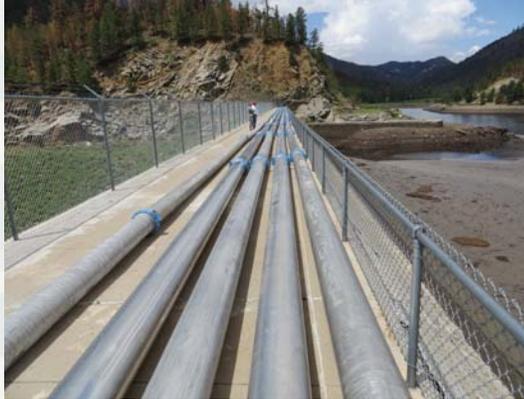
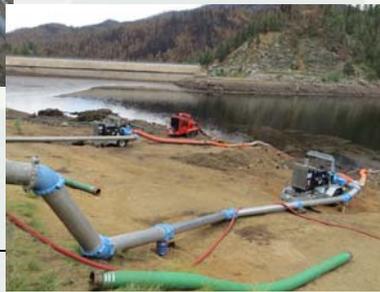
Total of 5 pumps:
4 - 12" and 1 - 8"
Max pump rate: 3,800 GPM ea.

8,000 feet of aluminum pipe

Drawdown rate:
• ~ 1 feet/day to 2 feet/day

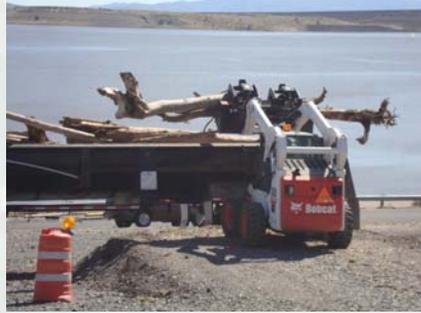
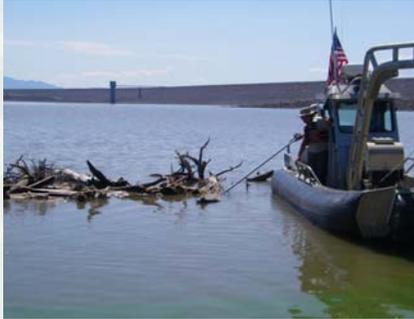
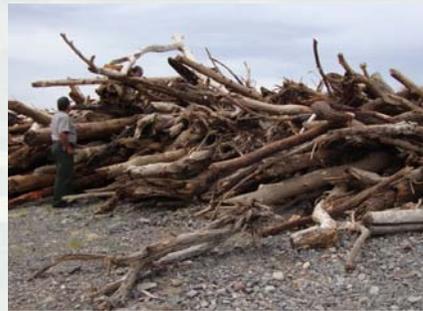
Approximately 100 tons of woody debris were removed from the surface of the lake.

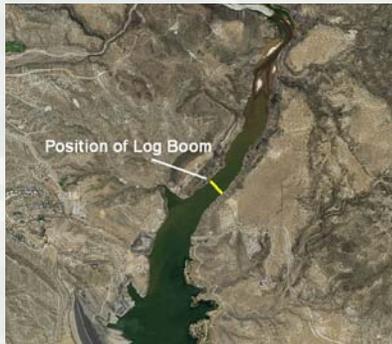
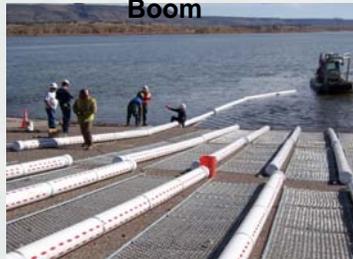
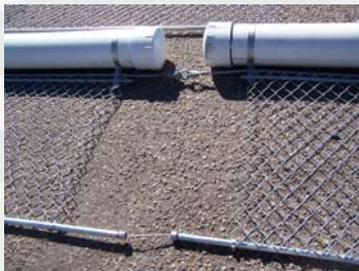
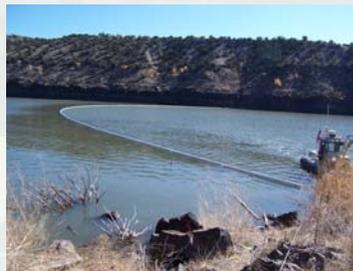
Debris Containment Boom

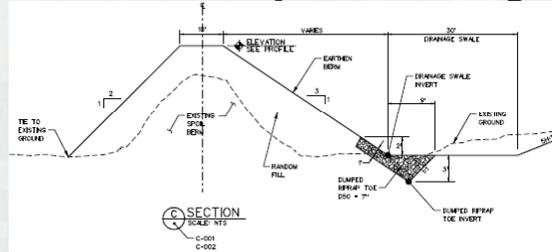
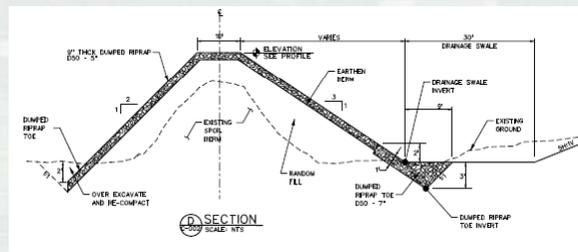
Technical Assistance Reports Conceptual Design
