REPORT DOCUMENTATION PAGE		READ INSTRUCTIONS BEFORE COMPLETING FORM
1. REPORT NUMBER Policy Study - 84-PS-3	2. GOVT ACCESSION NO.	3. RECIPIENT'S CATALOG NUMBER

4. TITLE (and Subtitle) An Evaluation of River Restoration Techniques in Northwestern Ohio		5. TYPE OF REPORT & PERIOD COVERED Policy Study
		6. PERFORMING ORG. REPORT NUMBER

AN EVALUATION OF  
RIVER RESTORATION TECHNIQUES  
IN NORTHWESTERN OHIO

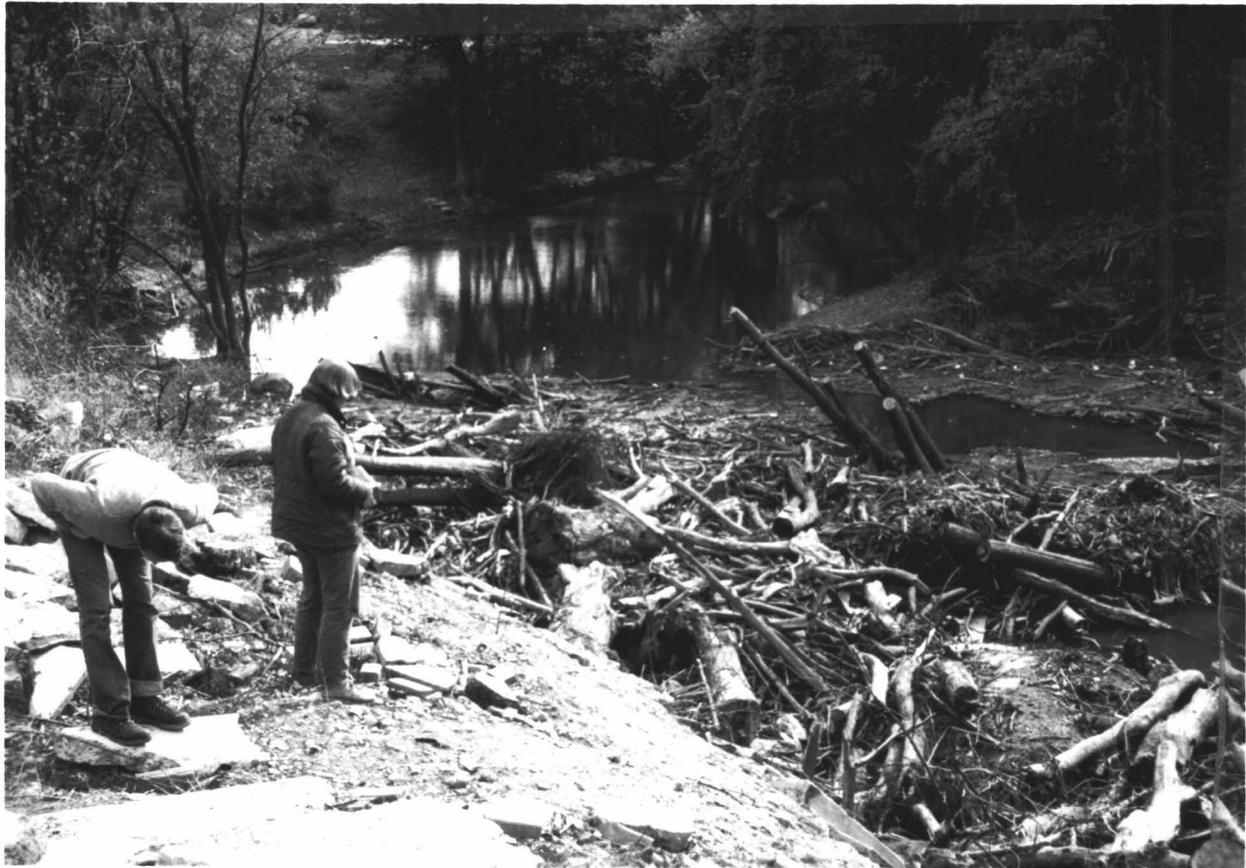
Logjams were common and large on these rivers when Mr. Palmiter conducted his first large-scale application of the techniques in 1975 and 1976. Figure 3 shows debris characteristic of these jams in the Blanchard River at Ottawa, Ohio. In some situations, the channel had cut deeply into the banks in order to find a flow path around the obstacles (see Figure 4). By removing the jams, the cross-sectional area of the stream was increased by an amount that varied with the size of the jam. It also reduced the hydraulic resistance in that region both by the removal of the sources of minor head losses due to

Figure 3. Debris in Blanchard River at Ottawa, Ohio

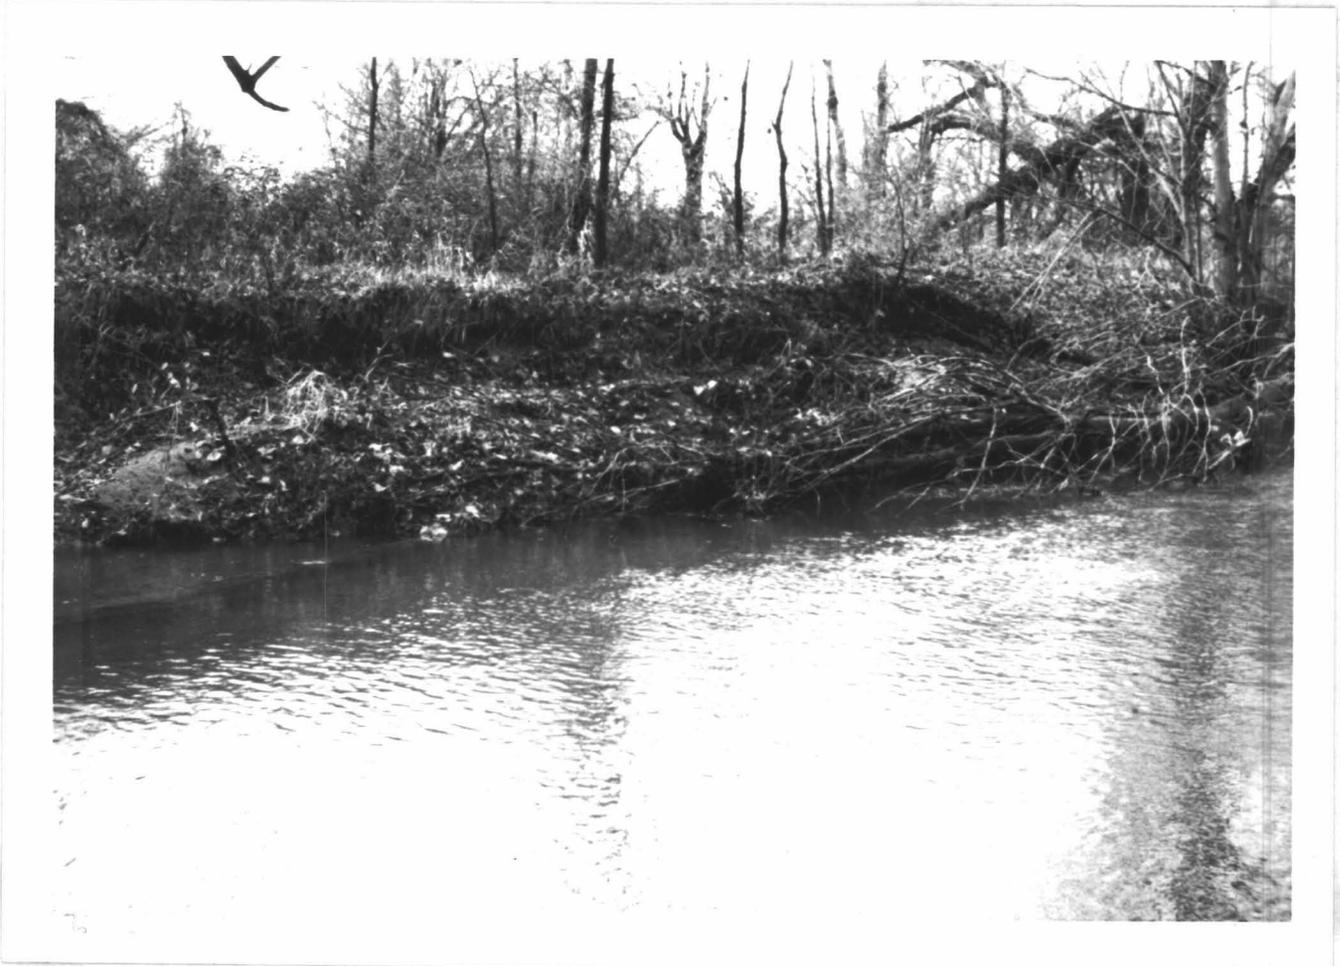
Figure 4. Bank Cutting

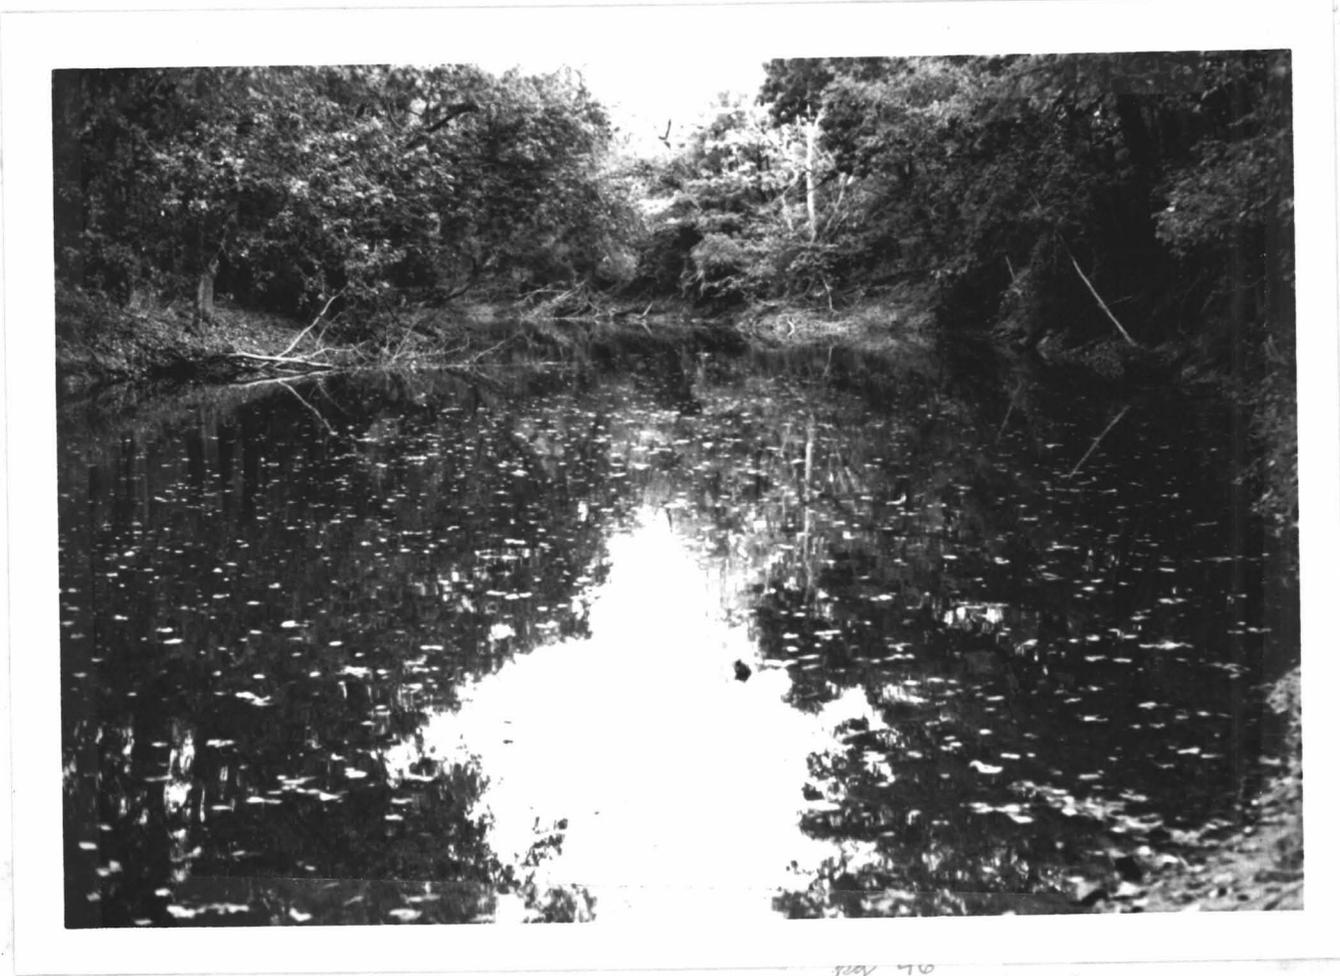
Figure 5. Mature Riparian Vegetation

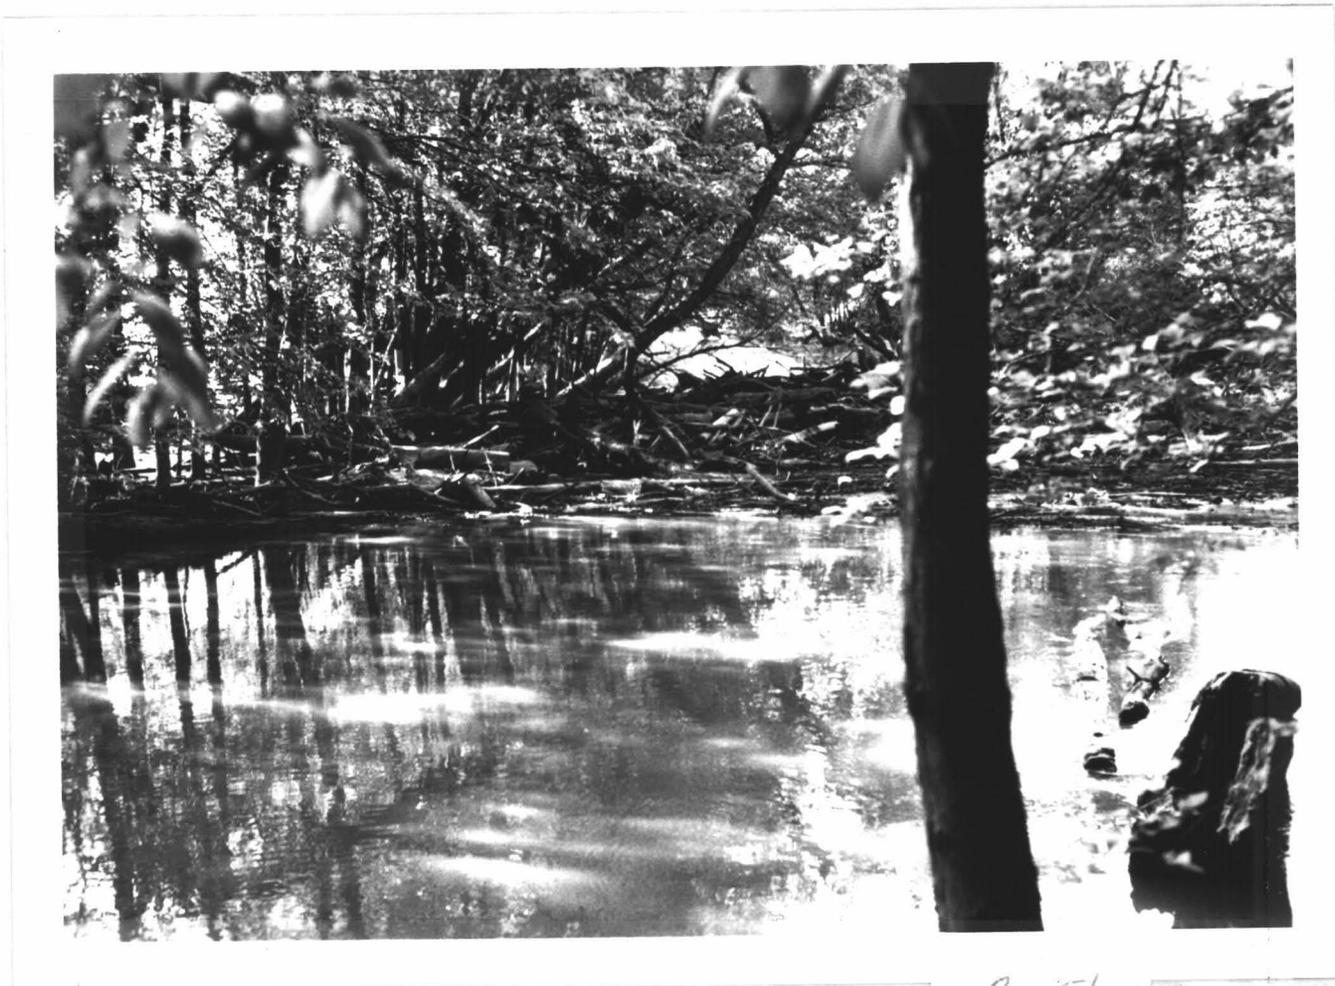
Figure 7. Small Logjam, Tiffin River below Stryker, Ohio

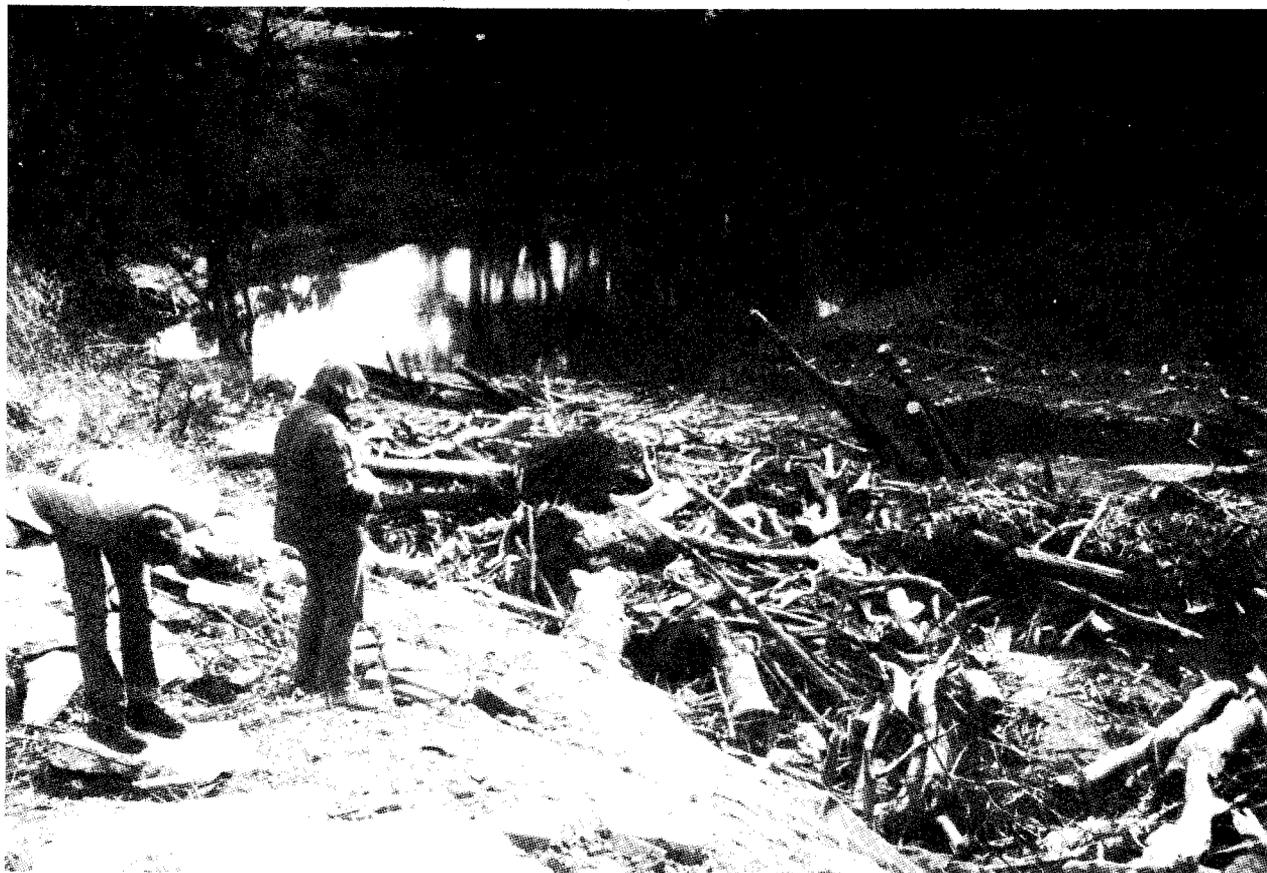
Logjams were common and large on these rivers when Mr. Palmiter conducted his first large-scale application of the techniques in 1975 and 1976. Figure 3 shows debris characteristic of these jams in the Blanchard River at Ottawa, Ohio. In some situations, the channel had cut deeply into the banks in order to find a flow path around the obstacles (see Figure 4). By removing the jams, the cross-sectional area of the stream was increased by an amount that varied with the size of the jam. It also reduced the hydraulic resistance in that region both by the removal of the sources of minor head losses due to

Figure 3. Debris in Blanchard River at Ottawa, Ohio

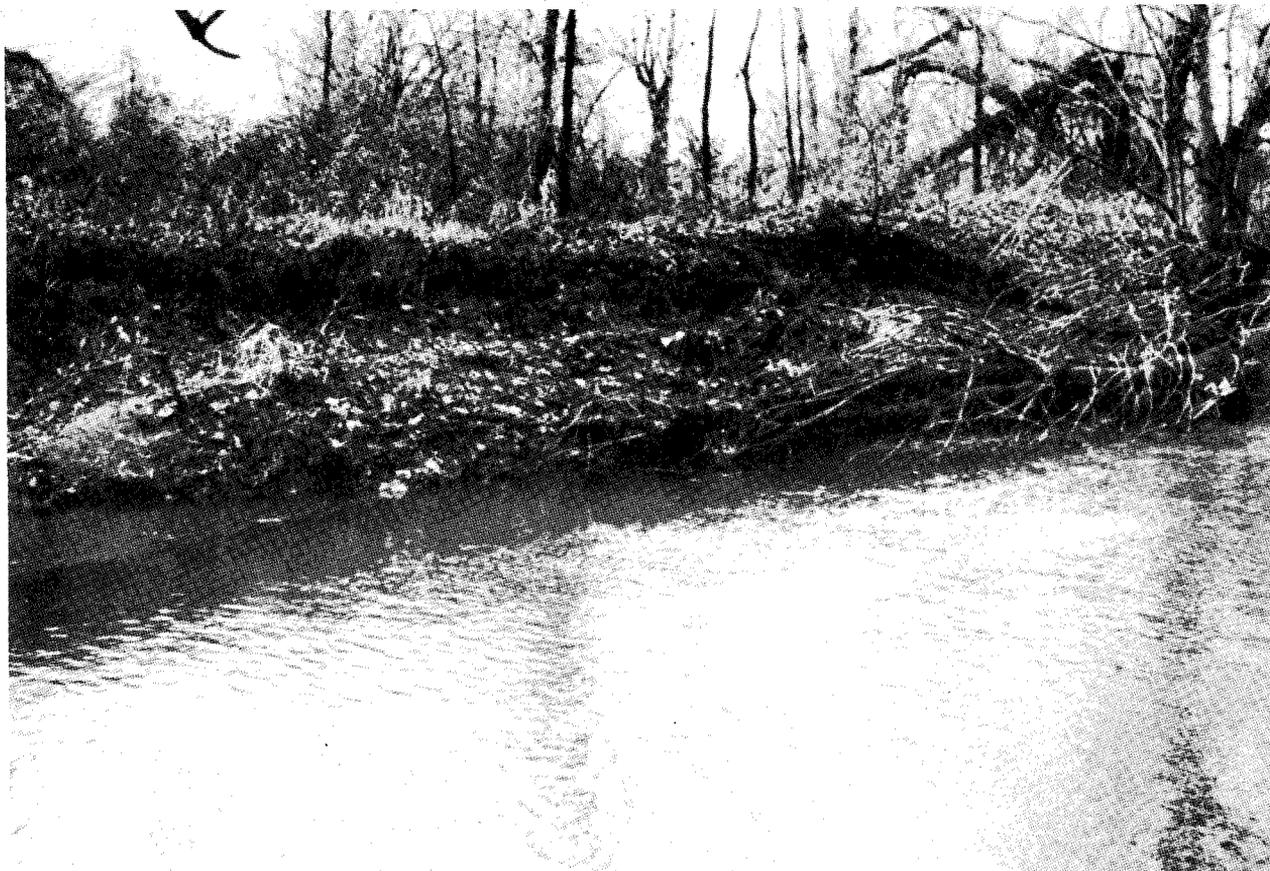
Figure 4. Bank Cutting

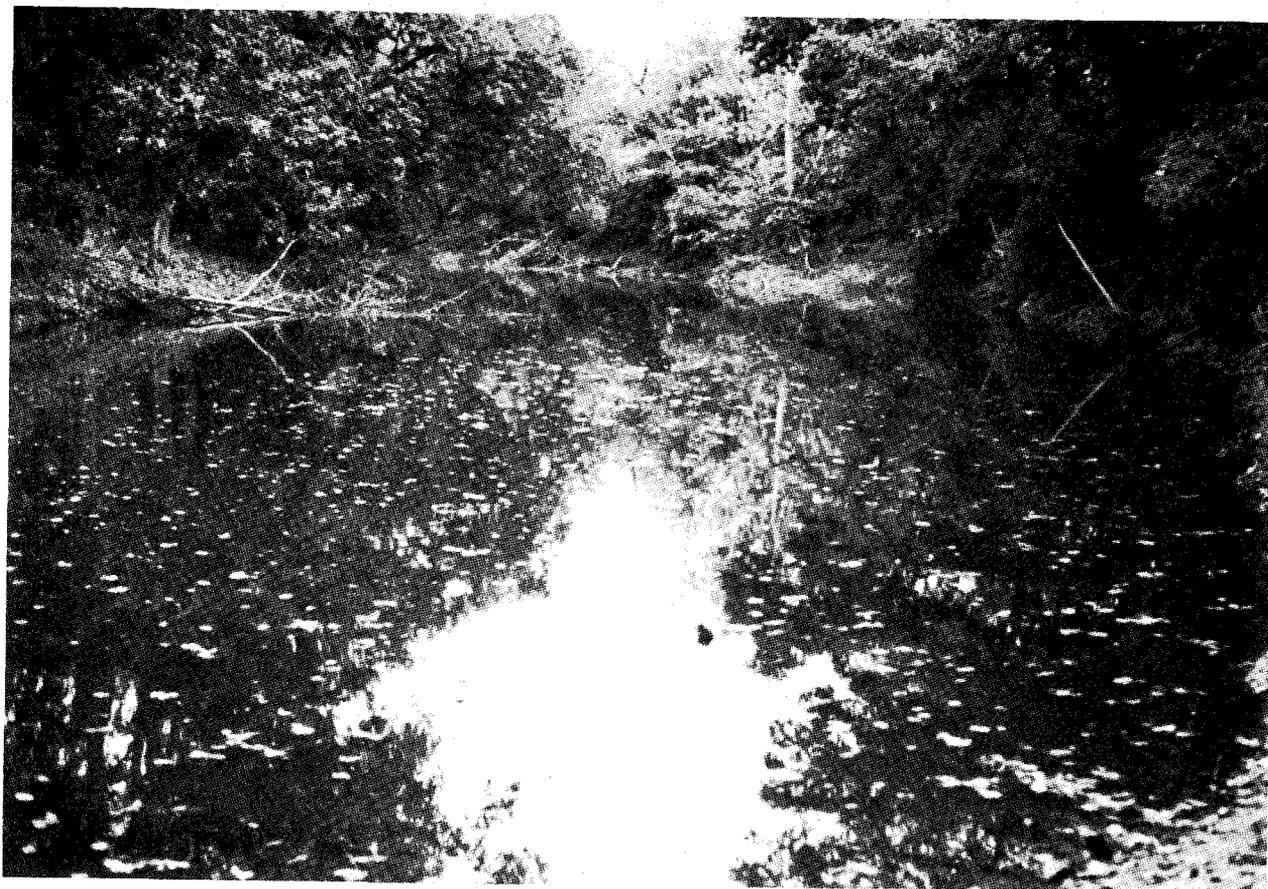
Figure 5. Mature Riparian Vegetation

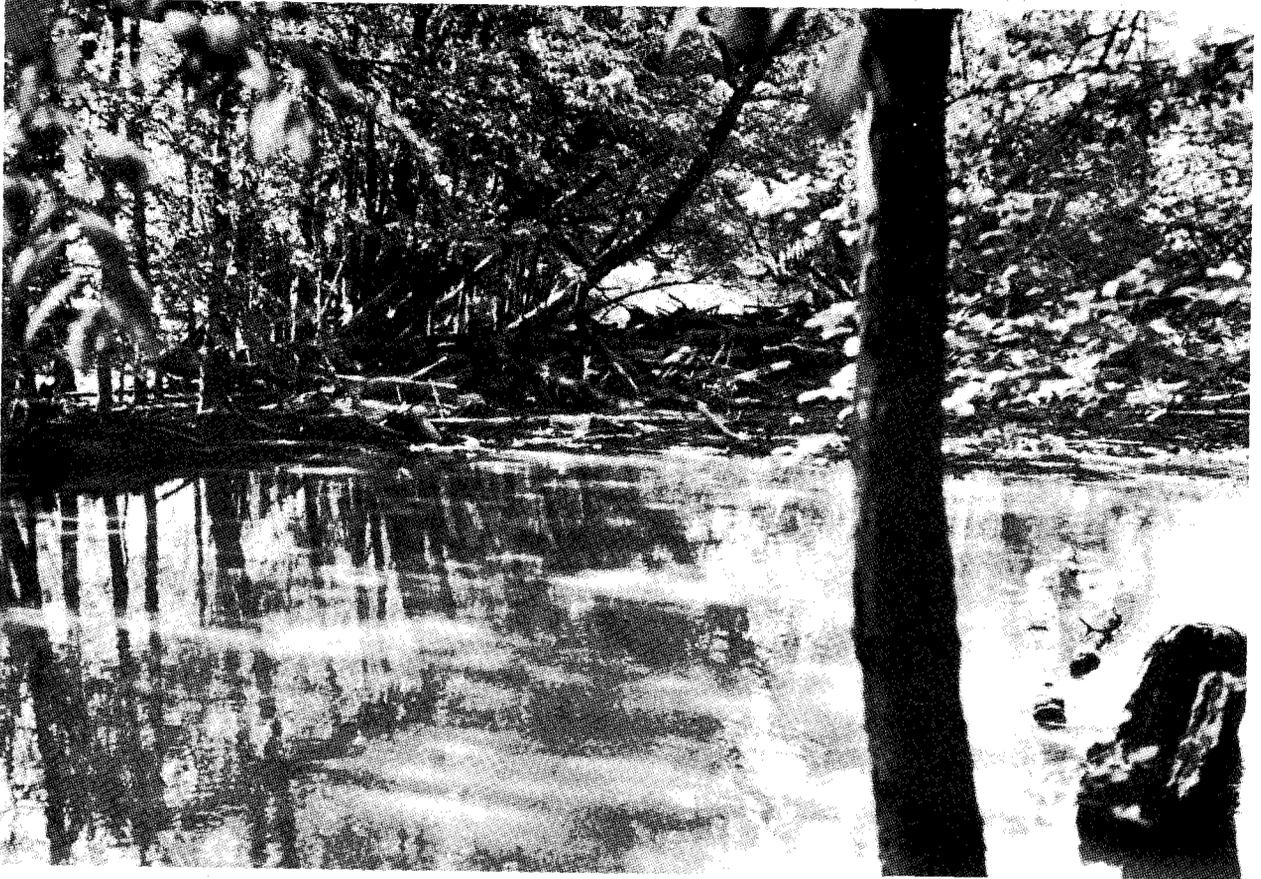
Figure 7. Small Logjam, Tiffin River below Stryker, Ohio
