Markland and Greenup Gate Failures

Chief, Operations
U.S. Army Corps of Engineers
Great Lakes and Ohio River Division

Markland Miter Gate Failure

Greenup Miter Gate Anchorage Failure

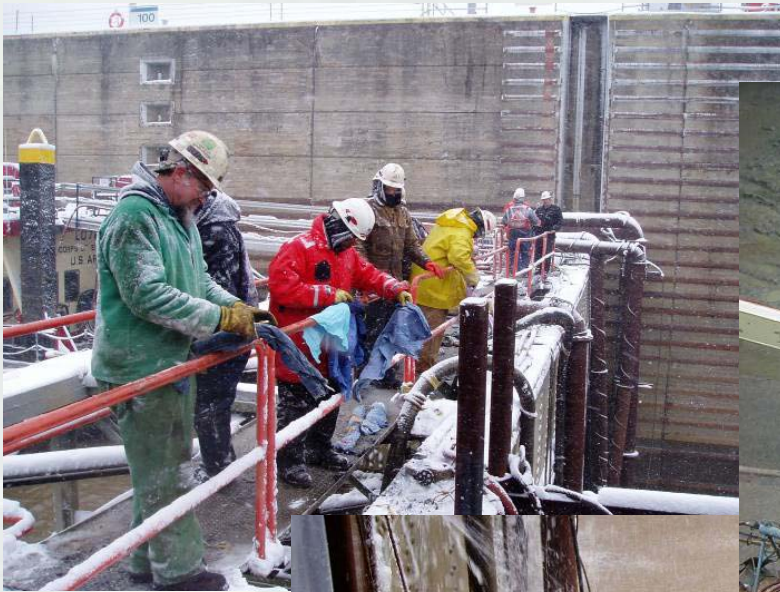
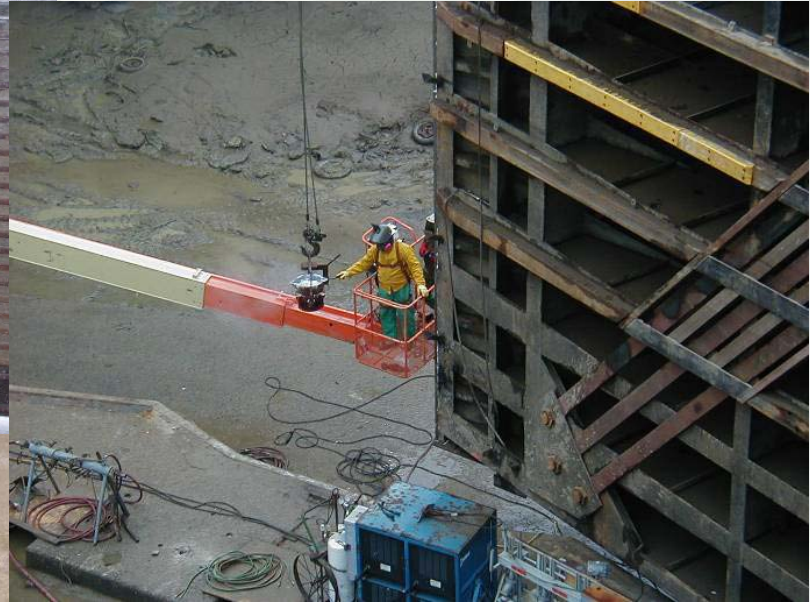
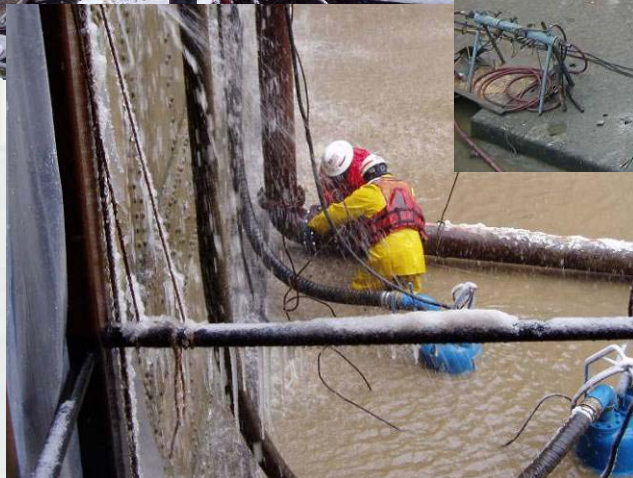
Repairs

- Fleet returns to Louisville to repair gate leaves on 13 November.
- Completed gate leaf repair 12 January 2010.
- Installation of repaired leaves was river dependent - the chamber had to be dewatered.

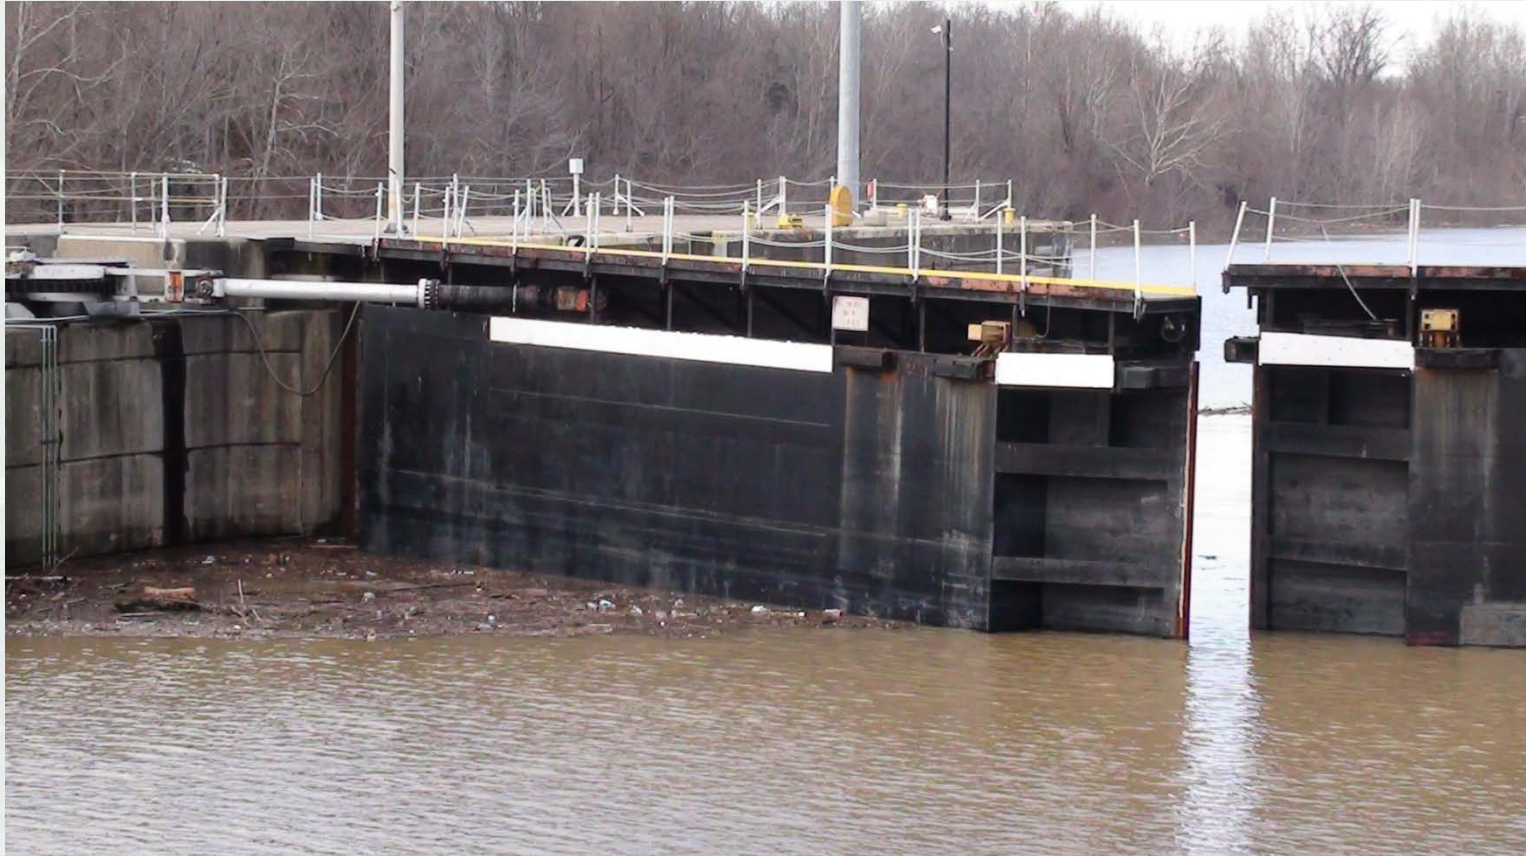
Miter Gate Anchorage Failure

Looking downstream – toe of gate dropped 1.2 ft

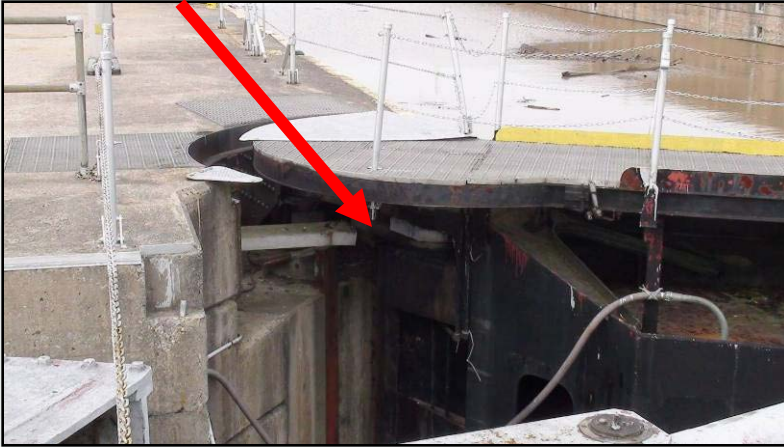
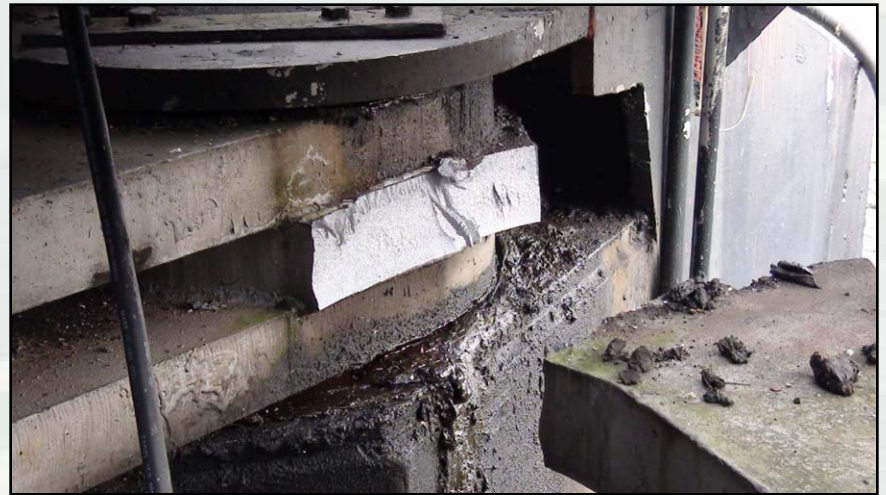
Miter Gate Anchorage Failure

Broken Anchorage Arm

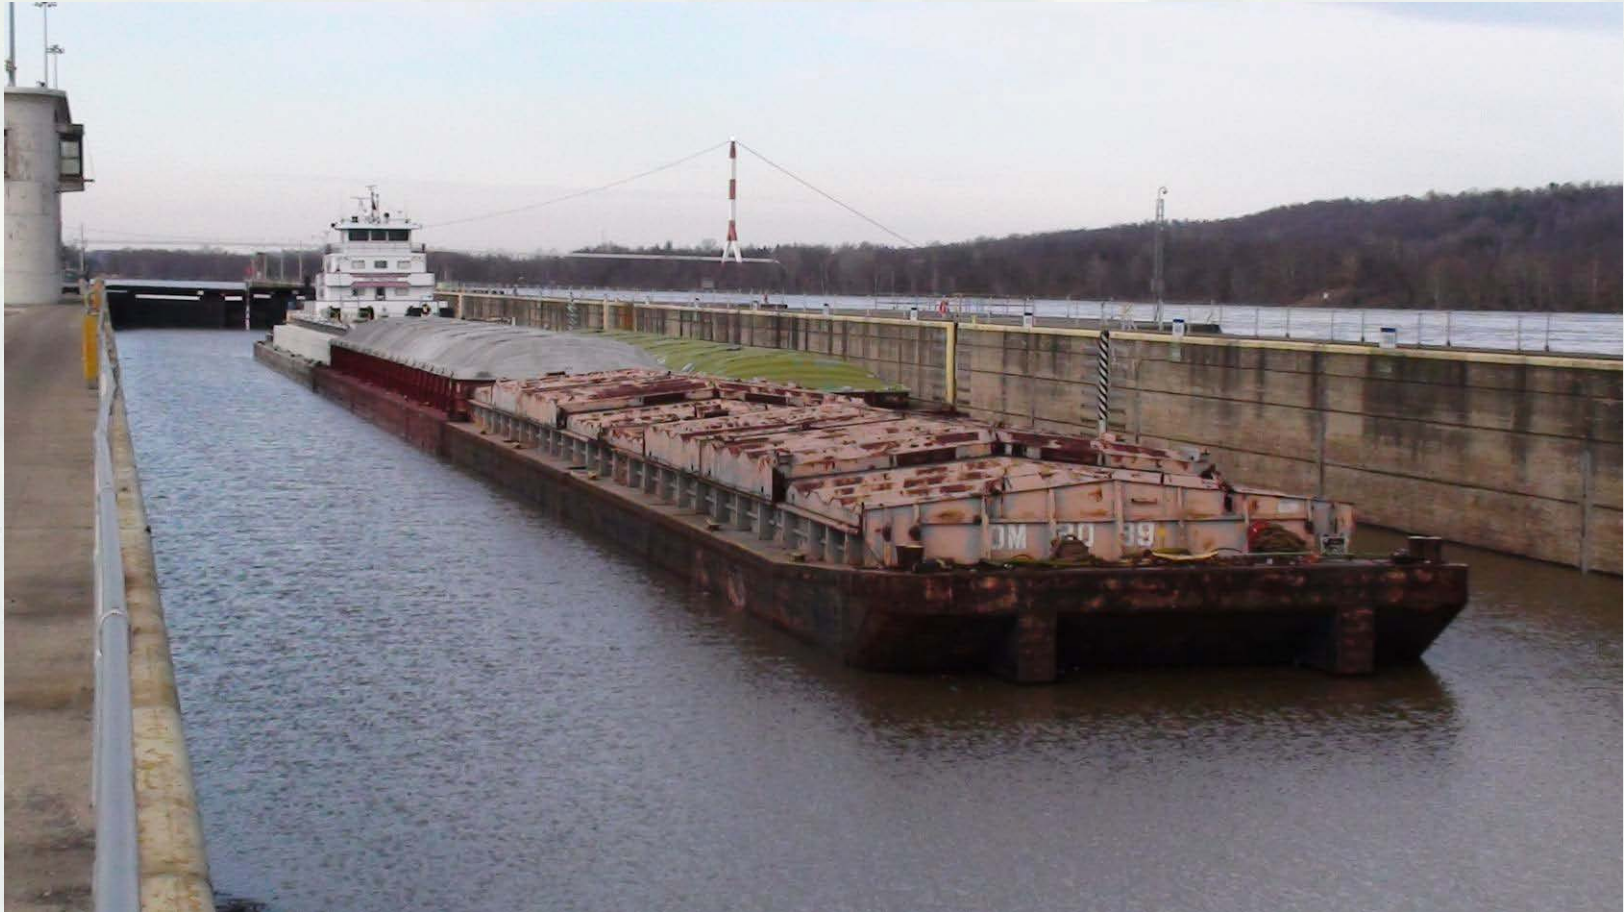
Tow in Main Chamber – 3 Days

Could not remove till the miter gate was stabilized

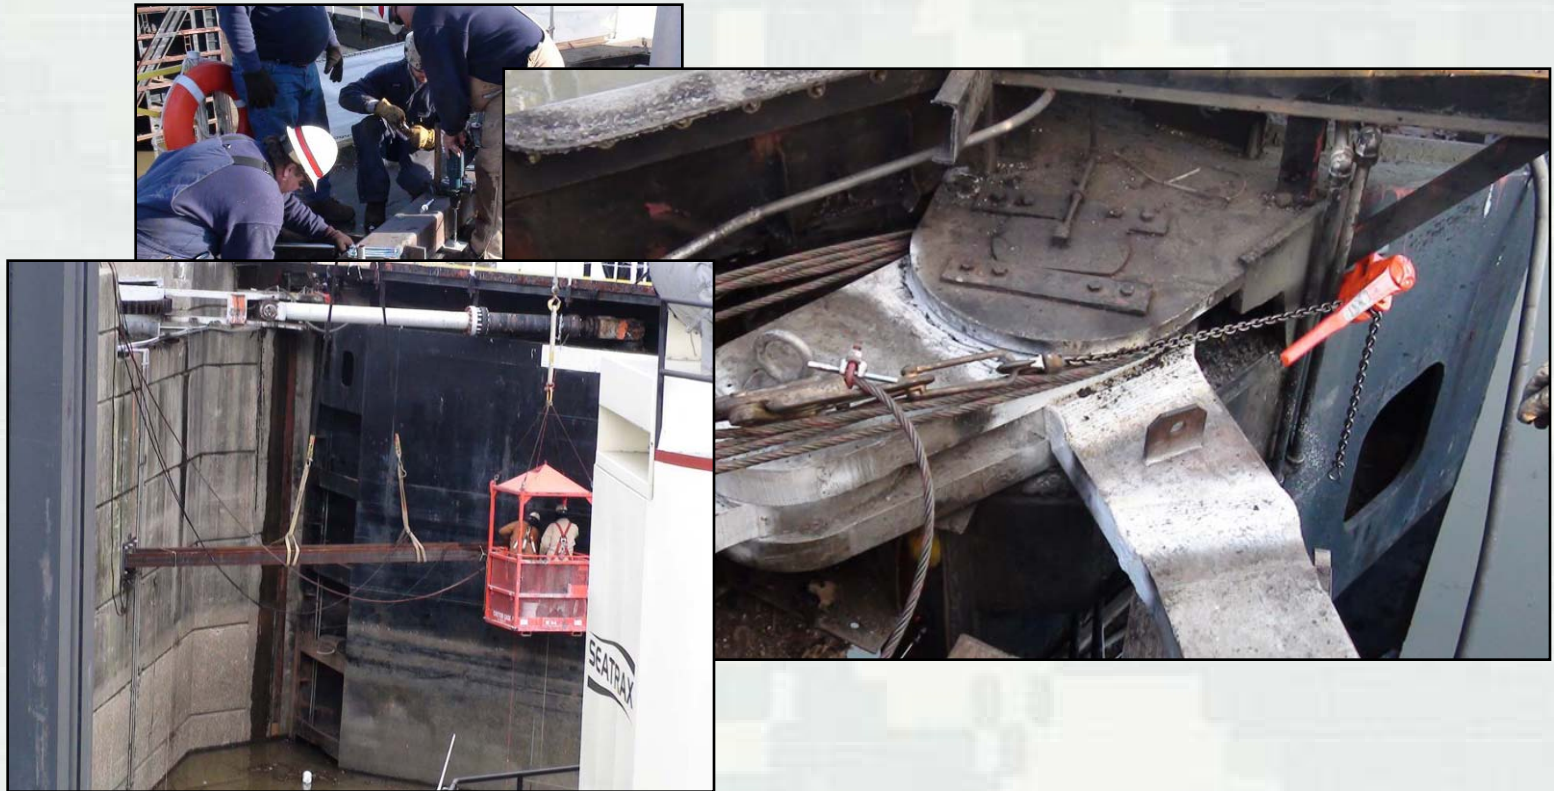
Additional Stabilization Efforts

Support anchor for anchorage bar that did not fail

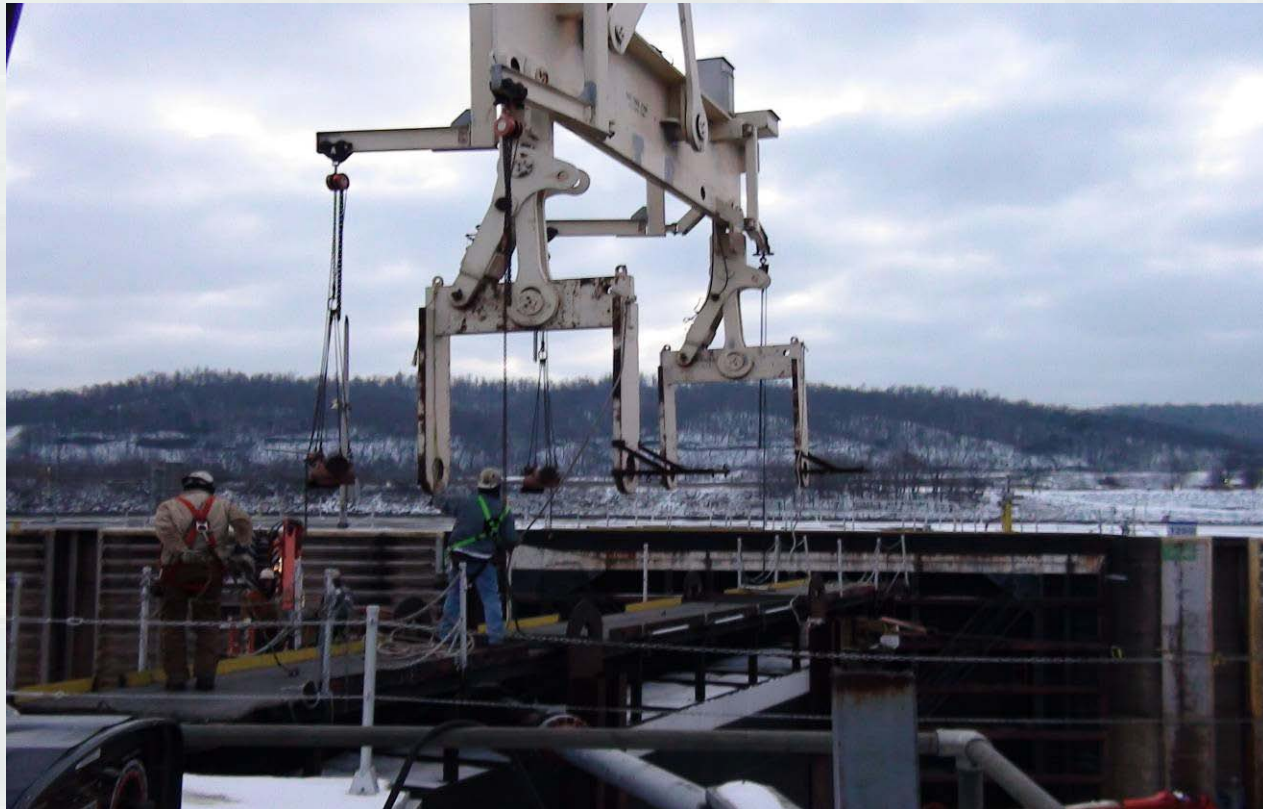
Connection of Lifting Beam

Gate Lifter “Shreve” arrived from
Louisville District on 6 Feb

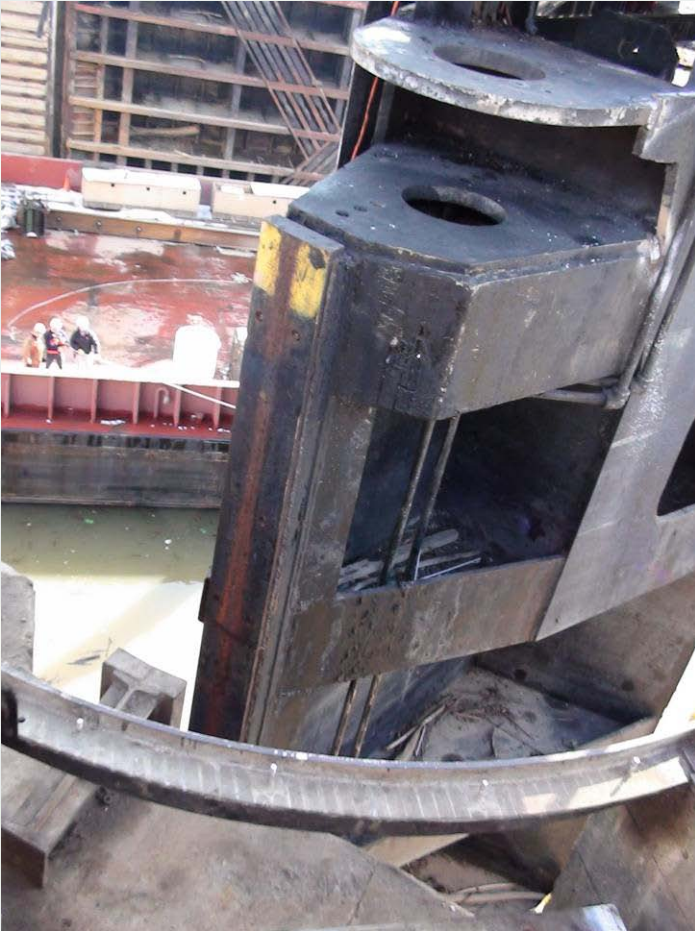
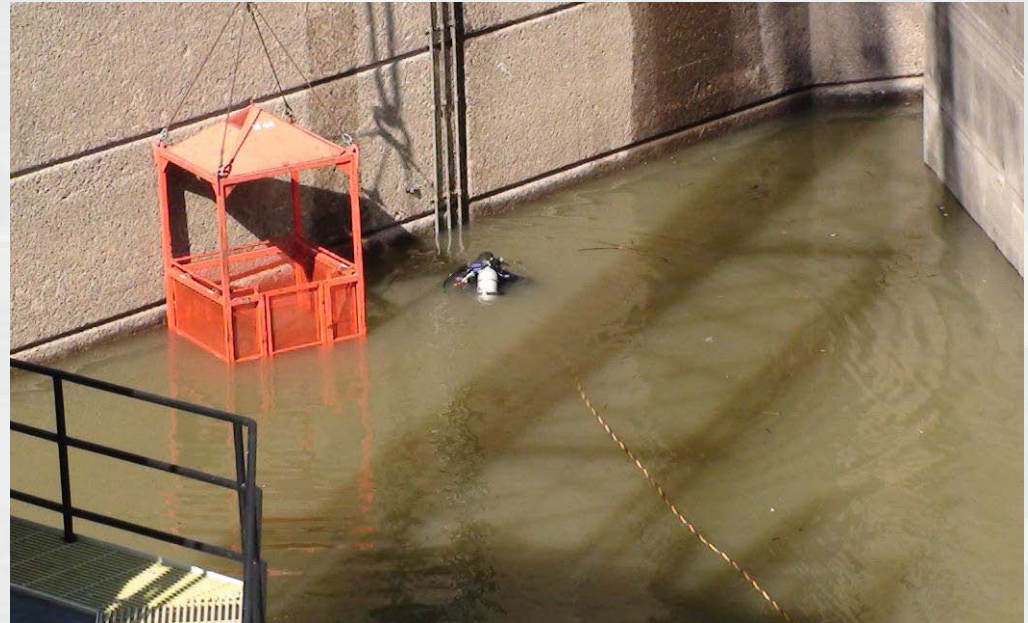
Reinstalling Miter Gate

Final alignment and dive inspection

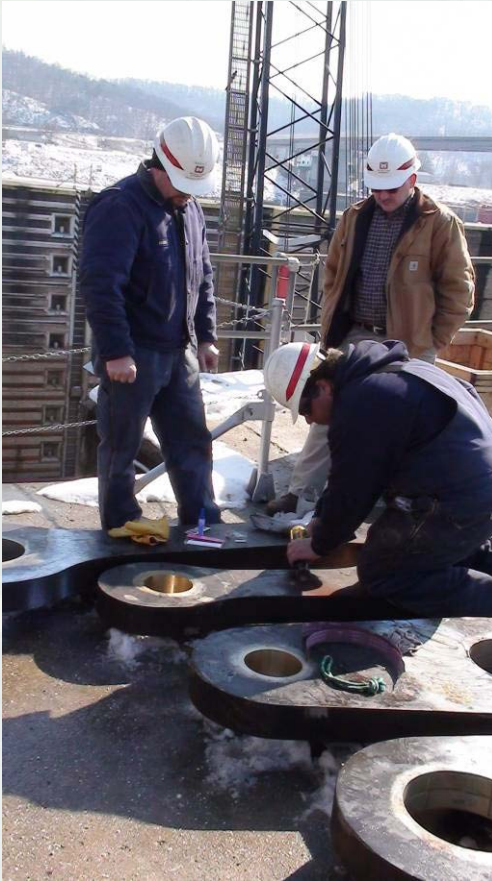
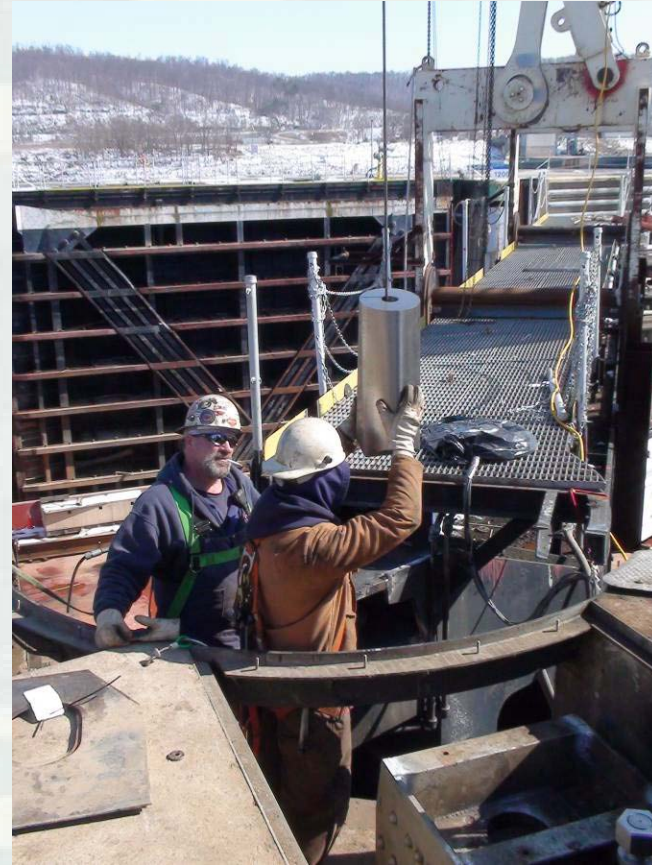
Reinstalling Miter Gate

Replacing anchorage arms, links and pins
