# DEMOPOLIS LOCK UPPER MITER SILL FAILURE

**RYAN REICH, P.E.**

Chief, Inland Navigation Section  
Operations, Mobile District

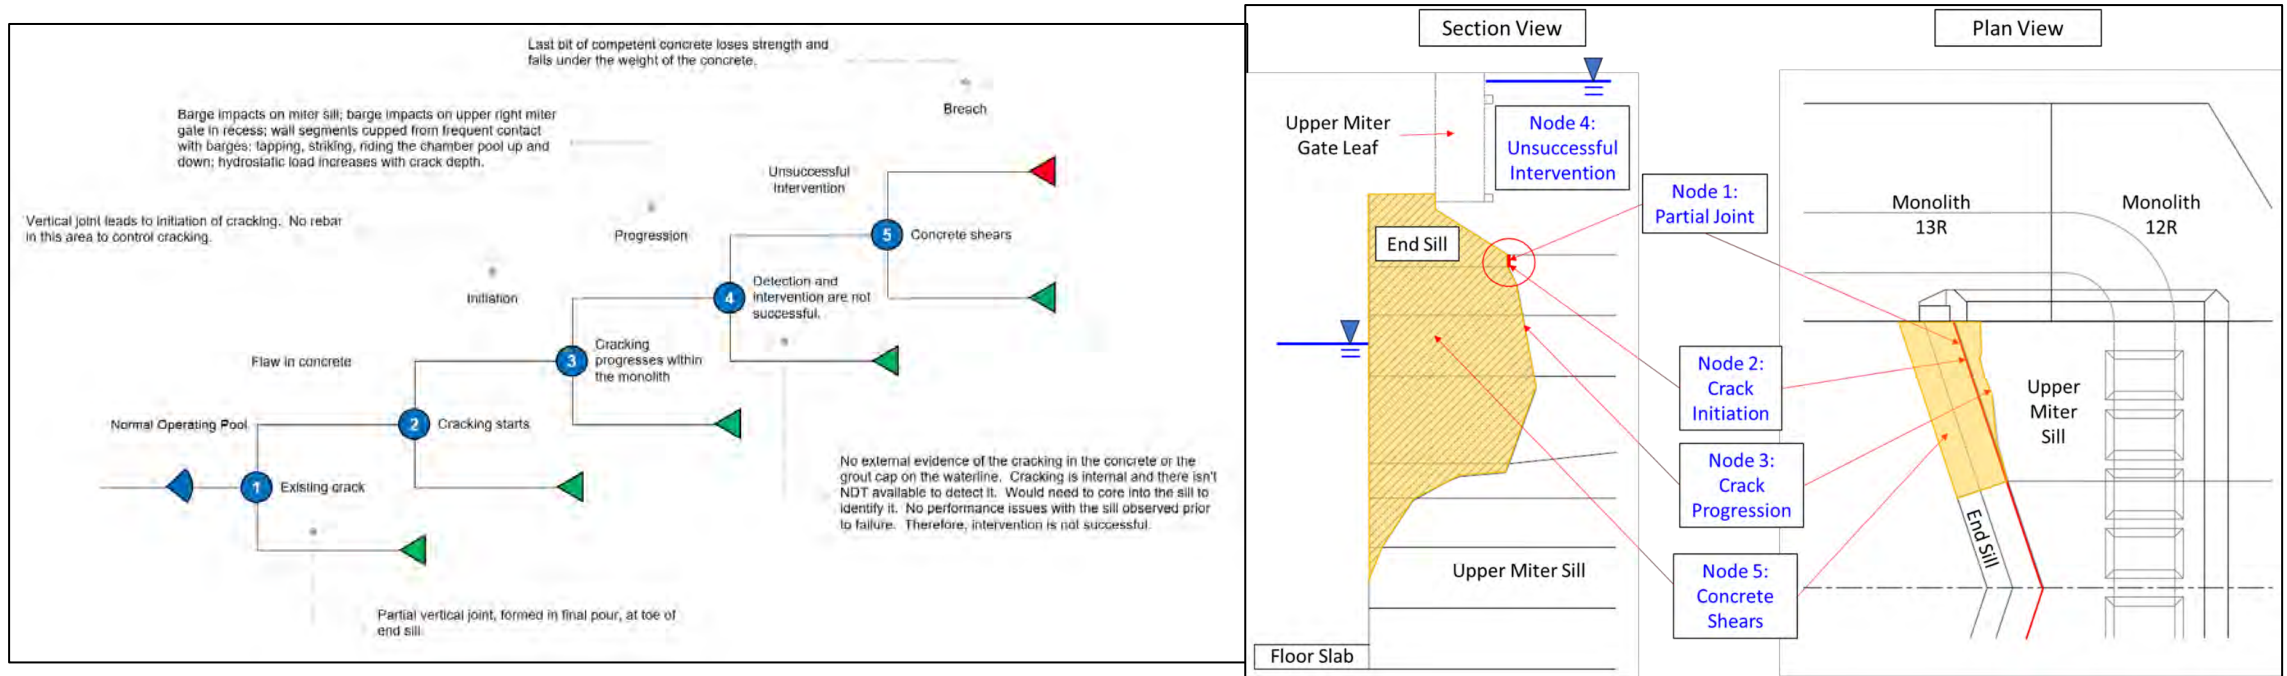
- PDT: SAM EN & OPs, ERDC, and LRP
- Reviewed background information (barge strikes, whirlpool from intake design, etc.)
- Brainstormed failure causes and discussed failure extensively
- Outlined potential failure mode and created event tree to explain and clarify breach
